University of Tasmania Sandy Bay Masterplan

Conservation Management Plan (Volume 2)

UTAS Sandy Bay Campus
Building Data Sheets
Volume 2

September 2021

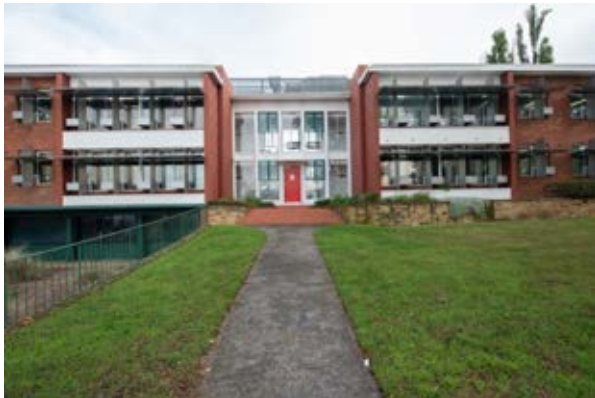
The building appears to be in reasonable condition, however a detailed inspection was not conducted.

Building 1 – 301 Sandy Bay Road
North-eastern elevation (Sandy Bay Road elevation)
Source: Paul Davies Pty Ltd

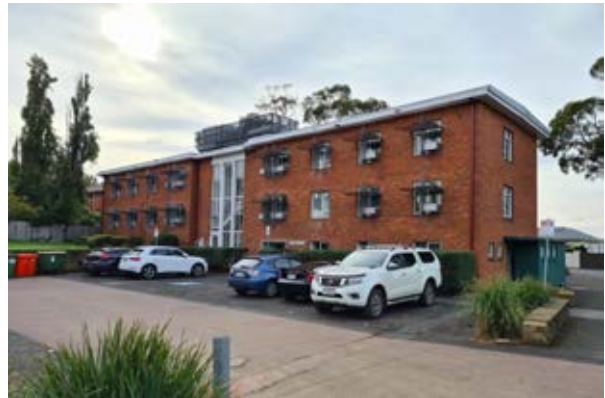
Building 1 – 301 Sandy Bay Road
South-western elevation
Source: Paul Davies Pty Ltd

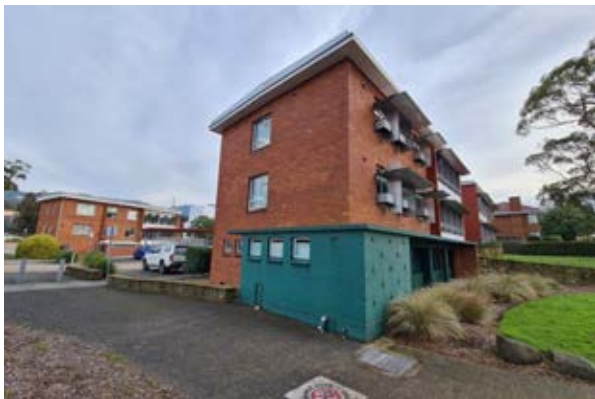
Building 1 – 301 Sandy Bay Road
South-eastern elevation
Source: Paul Davies Pty Ltd

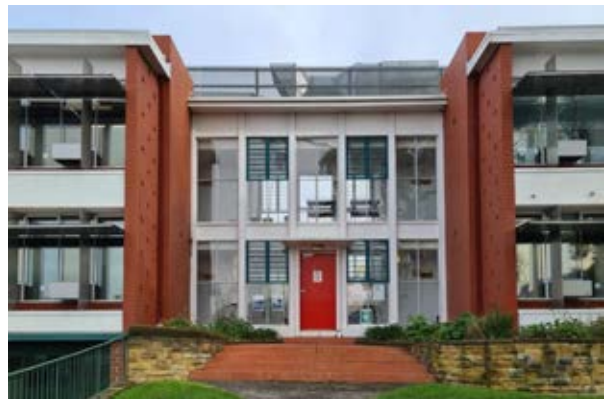
Building 1 – 301 Sandy Bay Road
Detail of central stair circulation (Sandy Bay Road elevation)
Source: Paul Davies Pty Ltd

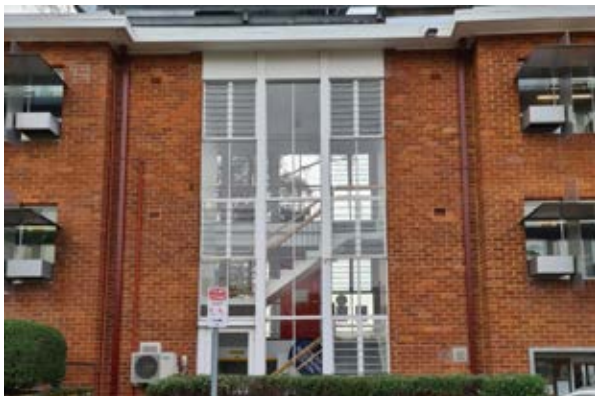
Building 1 – 301 Sandy Bay Road
Detail of central stair circulation (South-western elevation)
Source: Paul Davies Pty Ltd

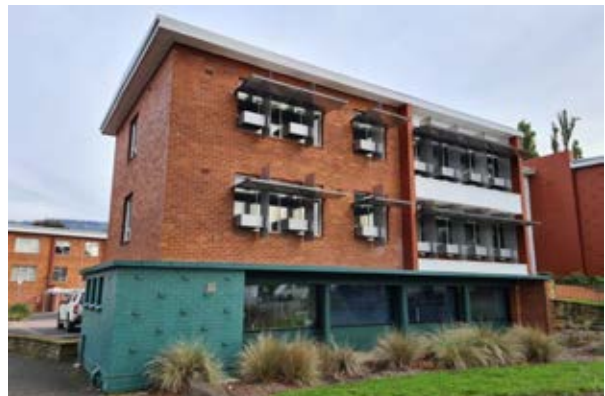
Building 1 – 301 Sandy Bay Road
Detail of the eastern wing facing Sandy Bay Road
Source: Paul Davies Pty Ltd

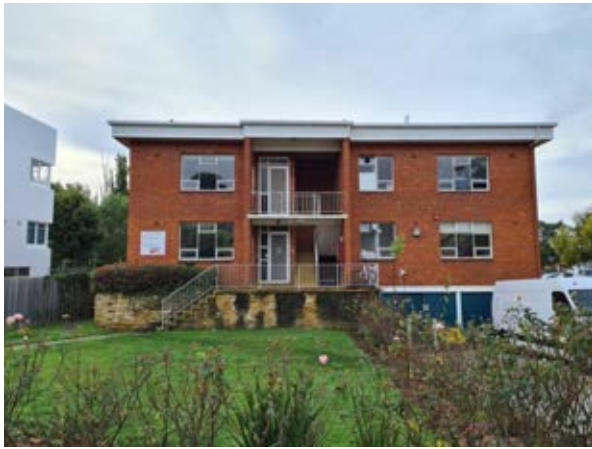
Condition	The building appears to be in reasonable condition, however a detailed inspection was not conducted.
-----------	--

Building 2 – 6 Grace Street
South-western elevation (Grace Street Elevation)
Source: Paul Davies Pty Ltd

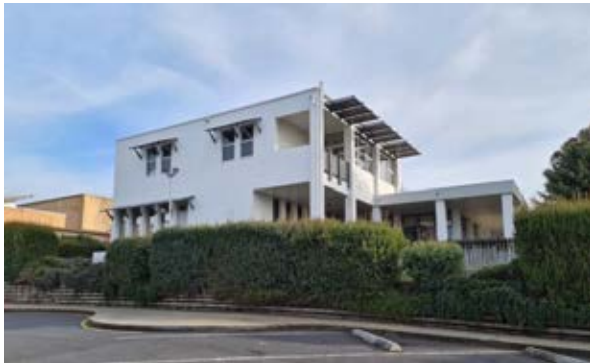
Interior Form	Interior not accessible during site inspection	
Significance	The building has no heritage significance in its current form.	
Key Elements	-	
Condition	The building appears to be in reasonable condition, however a detailed inspection was not conducted.

Building 3 – Childcare (Lady Gowrie)
North-eastern corner
Source: Paul Davies Pty Ltd

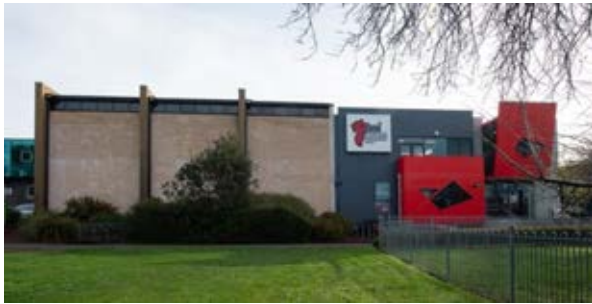
Description of Current Building	
Exterior Form	The original gymnasium is a steel portal frame structure with blond face brick walls. The main façade of the gym is broken into three bays with the metal clad steel columns expressed proud of the in-fill brick walls. Strips of hi-light windows are located above the brickwork and the metal-clad columns sail past these windows and return on top of the roof form. The roof has a minimal pitch with a central ridge. The gym has had numerous alterations and additions over the years and externally only the main gymnasium form remains visible and intact.
Interior Form	Interior not accessible during site inspection
Significance	The building has no heritage significance.
Key Elements	-
Condition	The building appears to be in reasonable condition, however a detailed inspection was not conducted.

Building 4 – Uni Gym
South-eastern elevation, original gymnasium form (image left)
Source: Paul Davies Pty Ltd

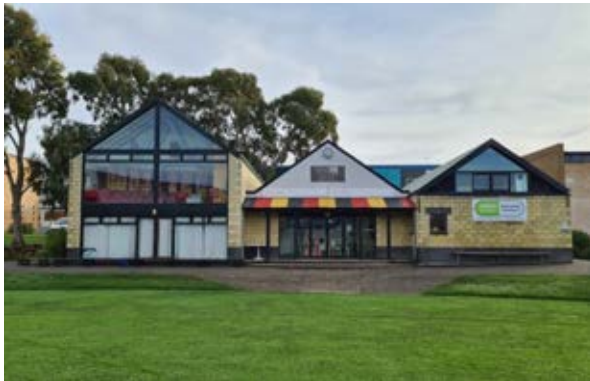
Interior Form	Interior not accessible during site inspection	
Significance	<p>The building was awarded an Institute of Architects Award.</p> <p>It does not have heritage significance.</p>	
Key Elements	-	
Condition	The building appears to be in fair condition, however a detailed inspection was not conducted.

Building 5 – Cricket Pavilion
South-eastern elevation (facing oval)
Source: Paul Davies Pty Ltd

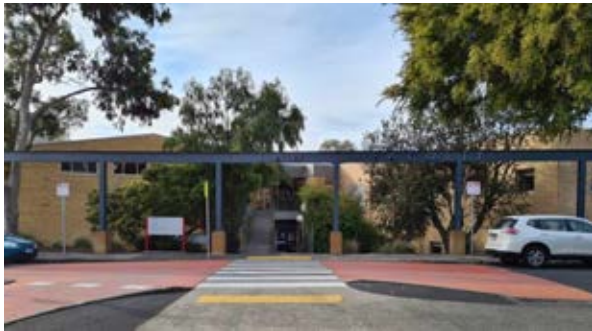
The building appears to be in reasonable condition, however an extensive inspection was not conducted.

Building 6 – Law Building
South-western elevation (main entrance)
Source: Paul Davies Pty Ltd

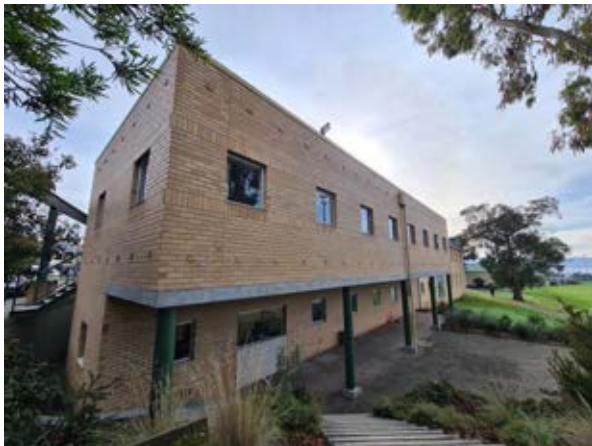
Building 6 – Law Building
South-eastern corner, showing the 1988 and 1990 extension.
Source: Paul Davies Pty Ltd

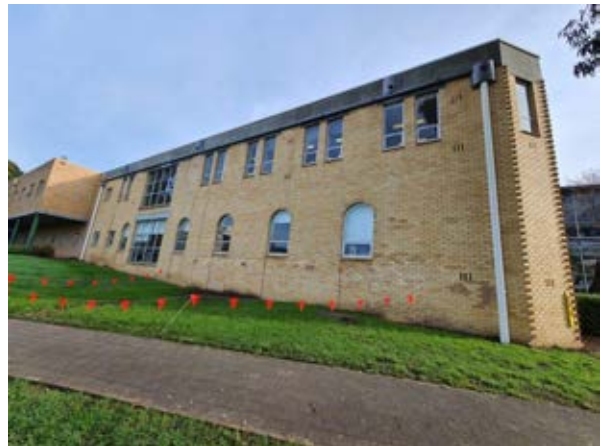
Building 6 – Law Building
South-eastern façade. This is the original façade from 1971 however several of the openings were enlarged as part of the 1988 alterations.
Source: Paul Davies Pty Ltd

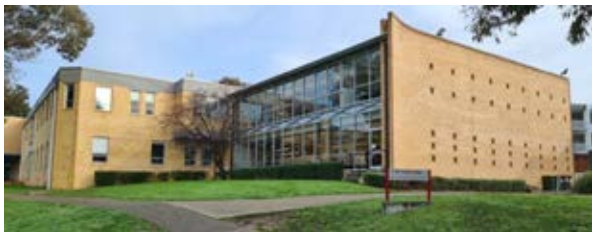
Building 6 – Law Building
North-eastern corner of the 1989 library extension
Source: Paul Davies Pty Ltd

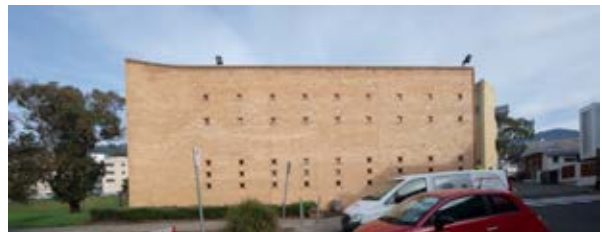
Building 6 – Law Building
Northern elevation of the 1989 library extension
Source: Paul Davies Pty Ltd

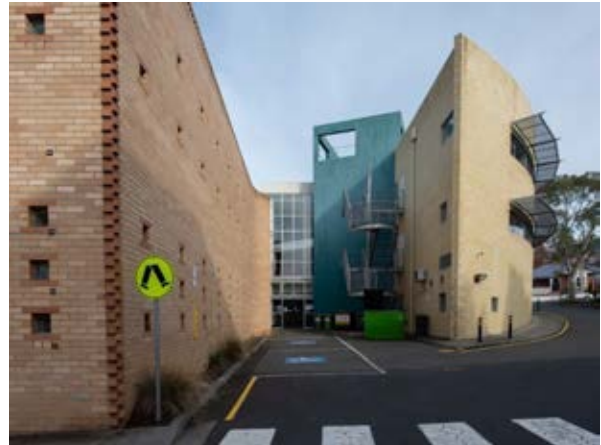
Building 6 – Law Building

1989 library extension (image left), 1993 postmodern extension (image right). Note the decorative hatched brickwork corner to the library extension.

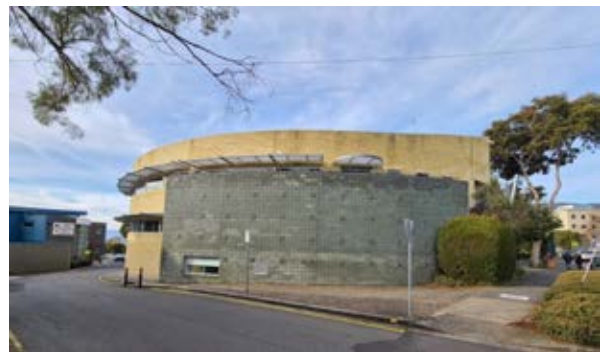
Building 6 – Law Building

South-western façade of the 1993 extension

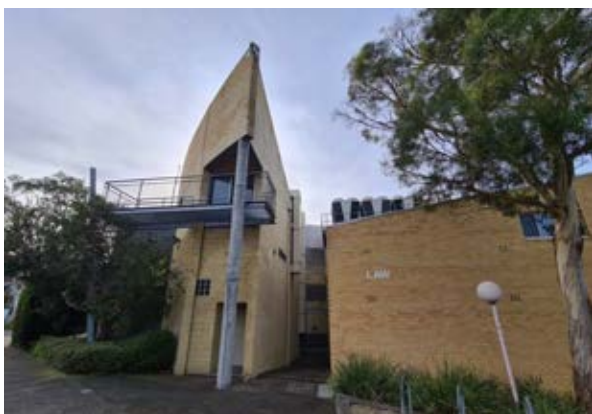
Building 6 – Law Building

South-western corner and junction between the original 1971 lecture theatre (image right) and the later 1993 extension

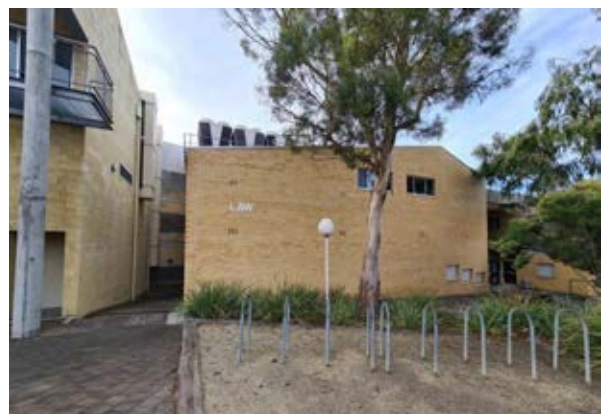
Building 6 – Law Building

South-western façade, showing the original 1971 lecture theatre (the two window openings at the top are not original).

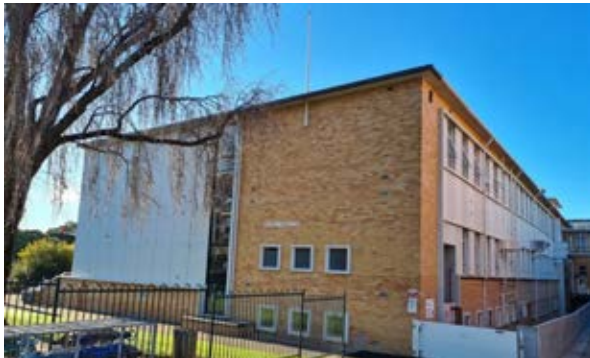
The building appears to be in good overall condition, however a detailed inspection was not conducted.

Building 8 – Engineering Building
North-western façade (facing Dobson Road)
Source: Paul Davies Pty Ltd

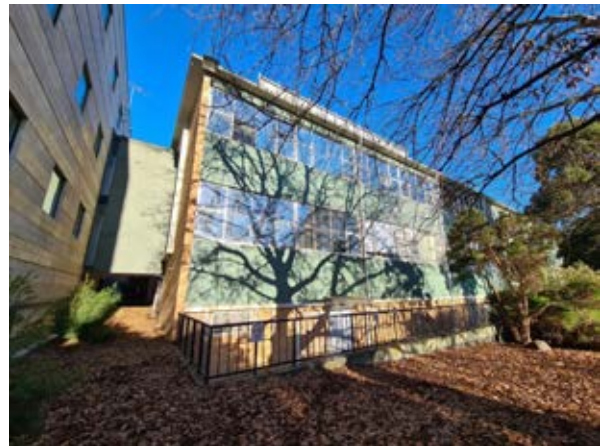
Building 8 – Engineering Building
Northern façade (eastern end)
Source: Paul Davies Pty Ltd

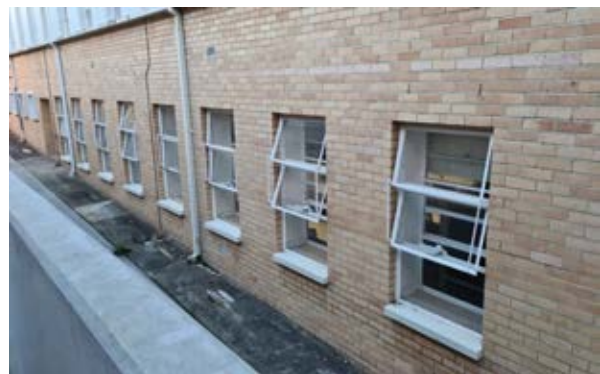
Building 8 – Engineering Building
Southern façade – steel window detail
Source: Paul Davies Pty Ltd

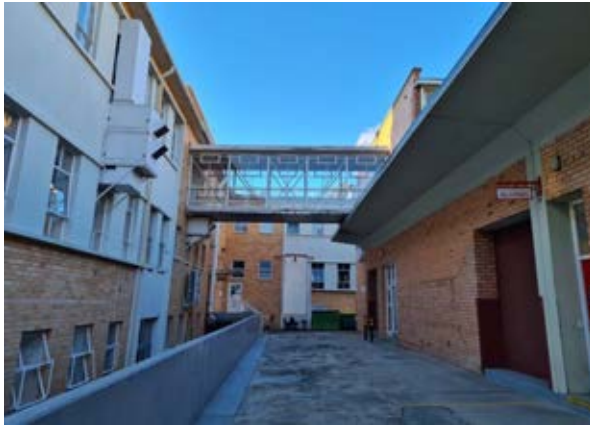
Building 8 – Engineering Building
Elevated bridge link between the Engineering Building and the Engineering Workshop
Source: Paul Davies Pty Ltd

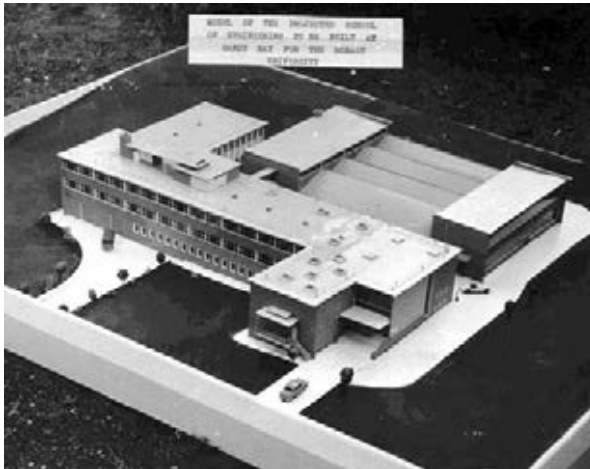
Building 8 – Engineering Building

Model of the Projected School of Engineering to be Built at Sandy Bay for the Hobart University

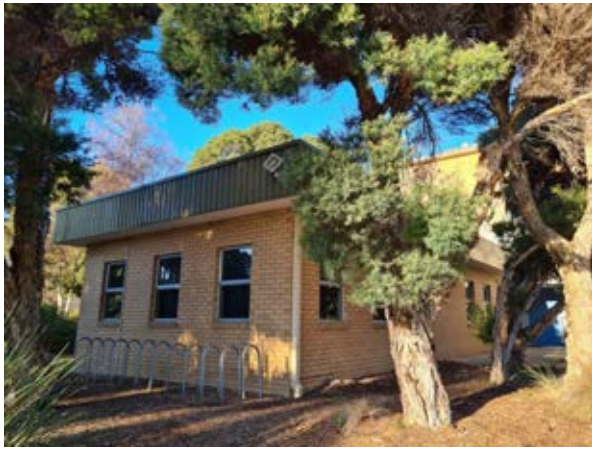
Interior Form	Interior not accessible during site inspection	
Significance	The building does not have heritage significance.	
Key Elements	-	
Condition	The building appears to be in reasonable condition, however a detailed inspection was not conducted.

Building 9 – Surveying Building
North-western corner, 1989 addition
Source: Paul Davies Pty Ltd

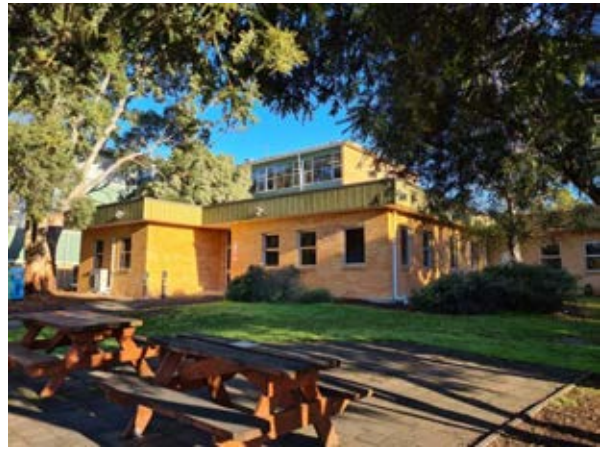
Building 9 – Surveying Building
North-eastern corner, original 1979 building
Source: Paul Davies Pty Ltd

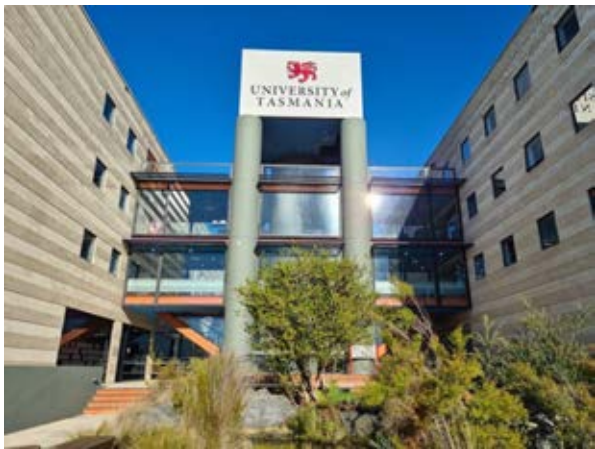
The building appears to be in reasonable condition, however an extensive inspection was not conducted.

Building 10 – Centenary Building
Northern Façade facing Grosvenor Crescent (main entrance)
Source: Paul Davies Pty Ltd

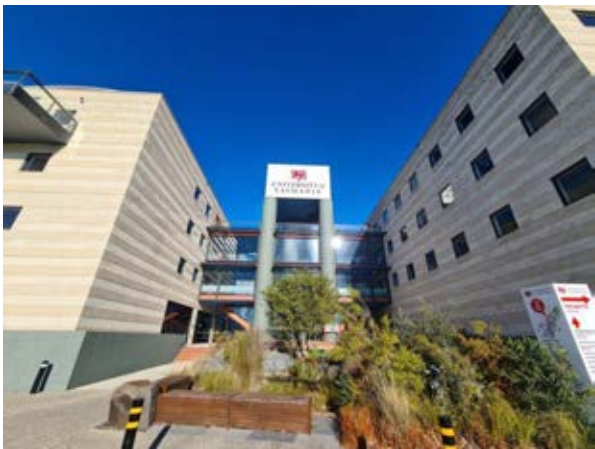
Building 10 – Centenary Building
Northern Façade facing Grosvenor Crescent (main entrance)
Source: Paul Davies Pty Ltd

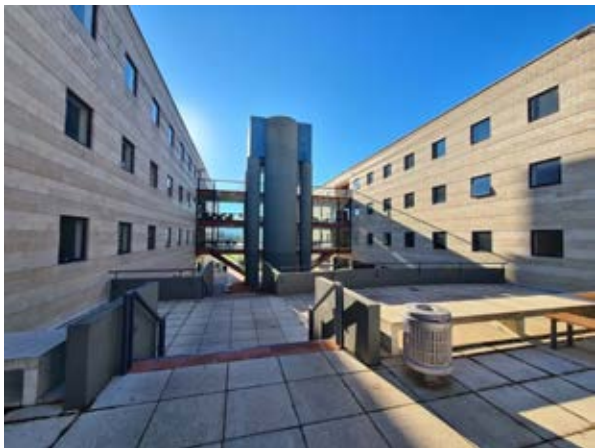
Building 10 – Centenary Building
Central Plaza between the eastern and western wings
Source: Paul Davies Pty Ltd

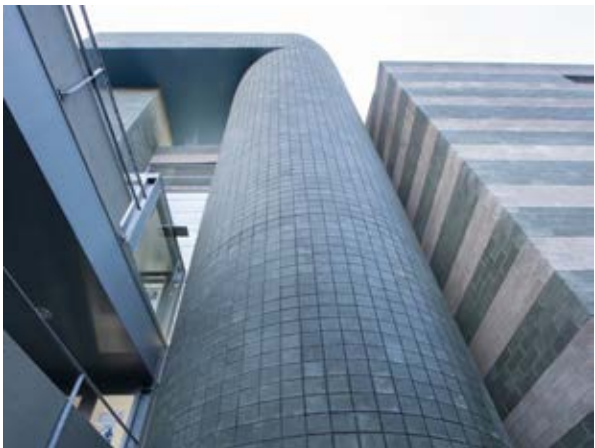
Building 10 – Centenary Building
Column Detail
Source: Paul Davies Pty Ltd

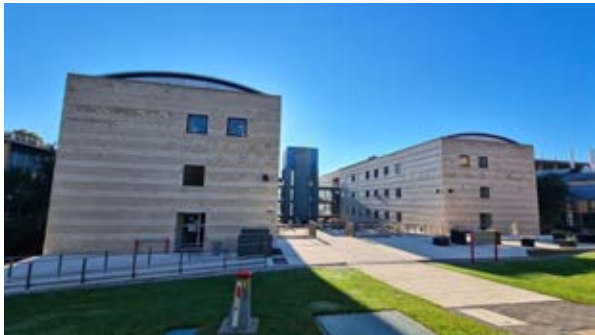
Building 10 – Centenary Building
Southern facade
Source: Paul Davies Pty Ltd

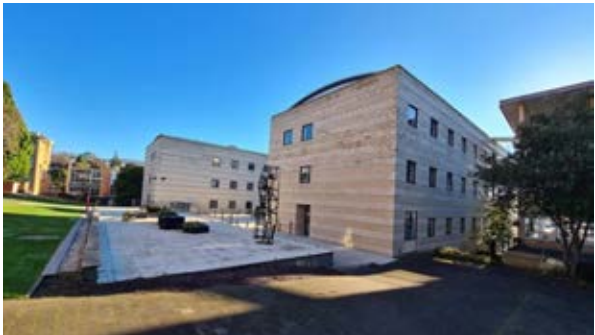
Building 10 – Centenary Building
South-eastern corner
Source: Paul Davies Pty Ltd

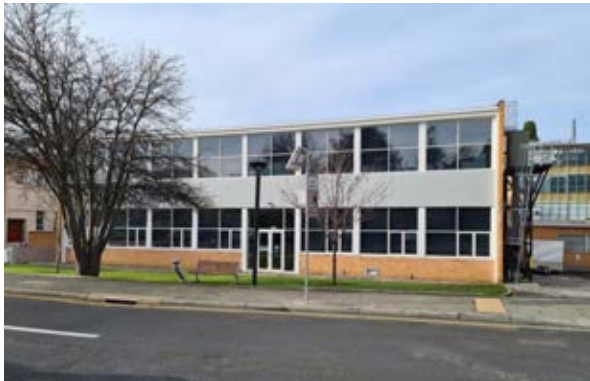
Condition	<p>The building appears to be in fair condition, however a detailed inspection was not conducted.</p>

Building 11 – Engineering Workshop
North-western façade – Dobson Road (main entrance)
Source: Paul Davies Pty Ltd

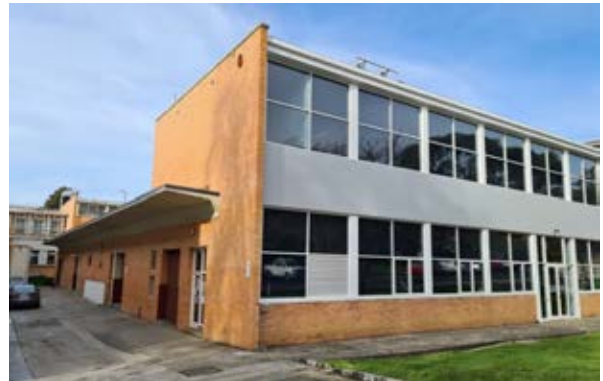
Building 11 – Engineering Workshop
North-western corner
Source: Paul Davies Pty Ltd

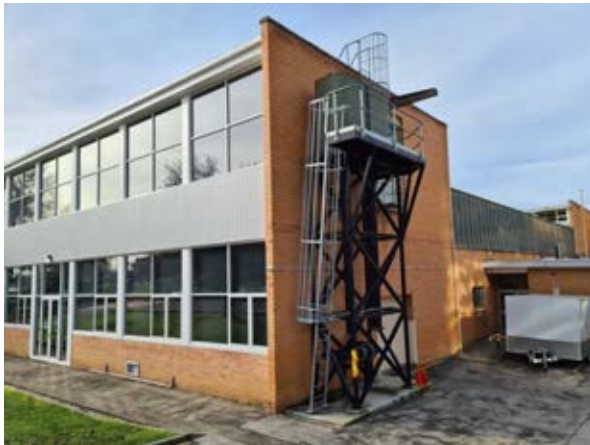
Building 11 – Engineering Workshop
South-western corner
Source: Paul Davies Pty Ltd

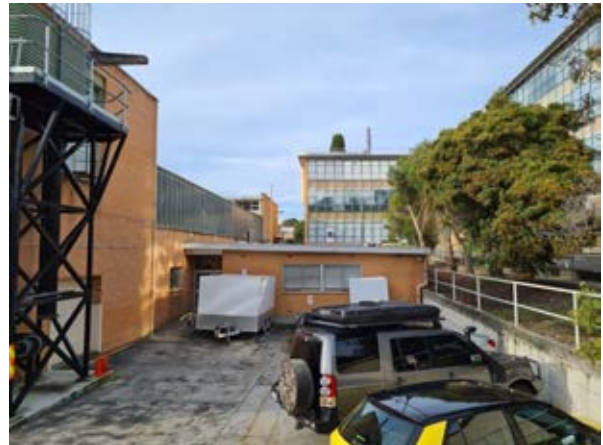
Building 11 – Engineering Workshop
1988 southern extension
Source: Paul Davies Pty Ltd

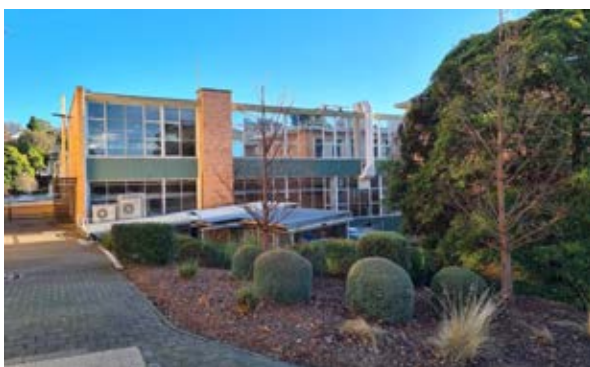
Building 11 – Engineering Workshop
Eastern facade
Source: Paul Davies Pty Ltd

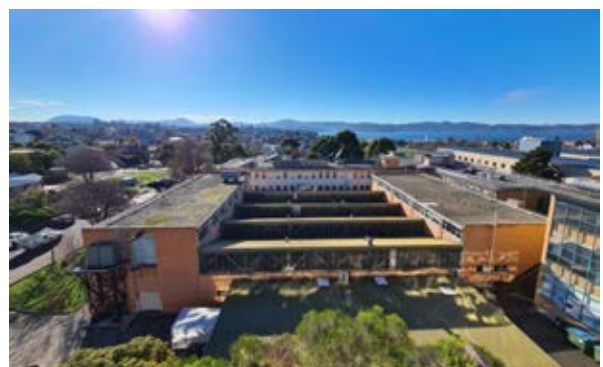
Building 11 – Engineering Workshop
View showing the central saw tooth roof form from the roof of the Chemistry Building looking north-east
Source: Paul Davies Pty Ltd

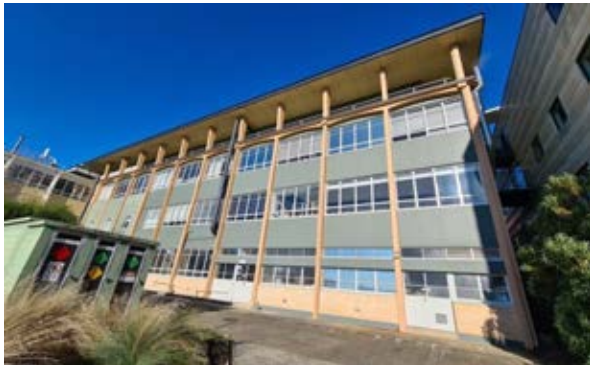
Key Elements	<ul style="list-style-type: none">- Early exterior form of the building, particularly the main entry area and eastern façade- The entrance foyer, terrazzo pattern and entry stair
Condition	<p>The building appears to be in good overall condition, however a detailed inspection was not conducted.</p>

Building 12 – Geography, Geology and CODES
Northern Façade facing Grosvenor Crescent with the 1988 fourth floor visible on top
Source: Paul Davies Pty Ltd

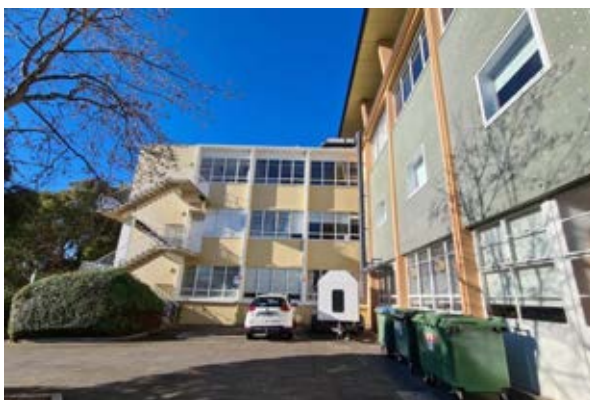
Building 12 – Geography, Geology and CODES
North-eastern wing (western façade)
Source: Paul Davies Pty Ltd

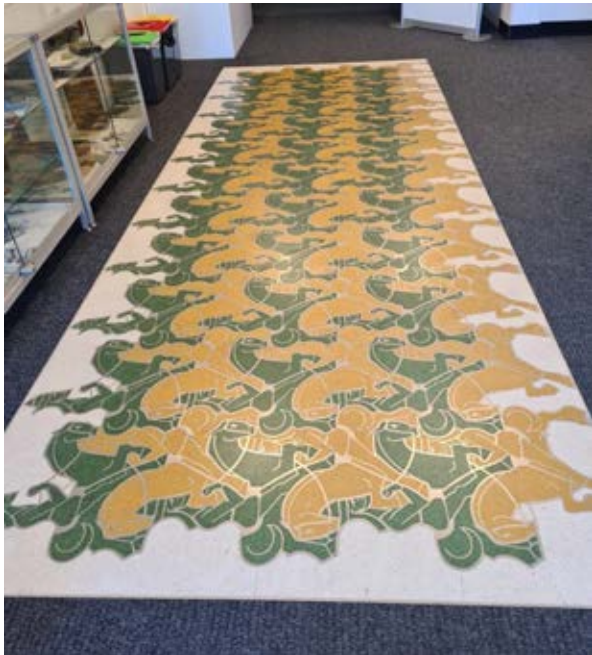
Building 12 – Geography, Geology and CODES
Clark Road Entrance Foyer – detailed tessellated terrazzo floor inlay
Source: Paul Davies Pty Ltd

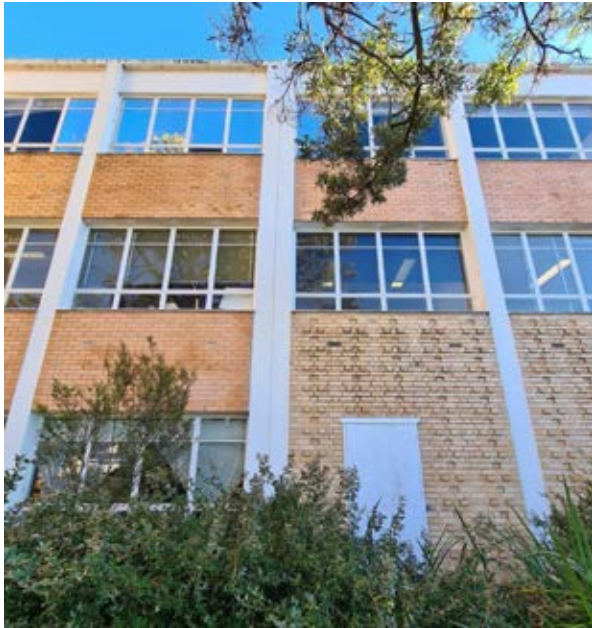
Building 12 – Geography, Geology and CODES
Detail of where the 1969 southern extension occurs is evident with the double column and change in brickwork detail
Source: Paul Davies Pty Ltd

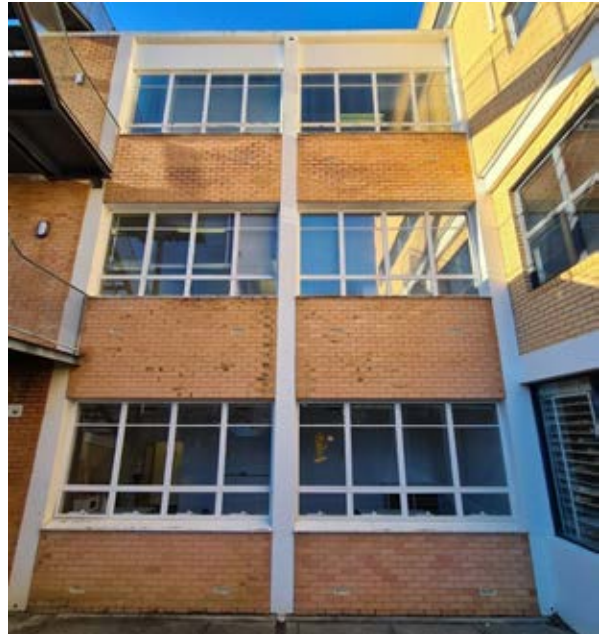
Building 12 – Geography, Geology and CODES
1969 southern extension – Detail of the western façade of the eastern wing
Source: Paul Davies Pty Ltd

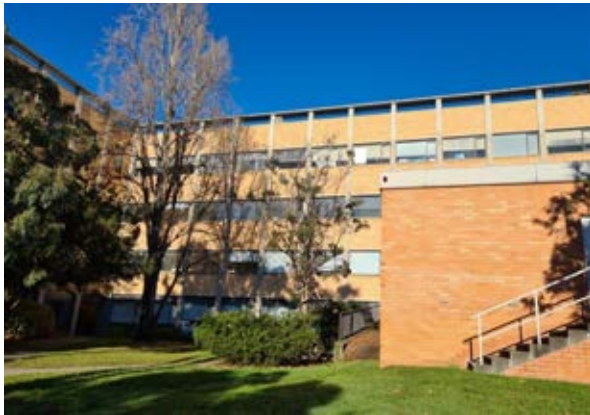
<p>Condition</p>	<p>The building appears to be in good overall condition, however a detailed inspection was not conducted.</p>

Building 13 – Physics
Original North-eastern Façade
Source: Paul Davies Pty Ltd

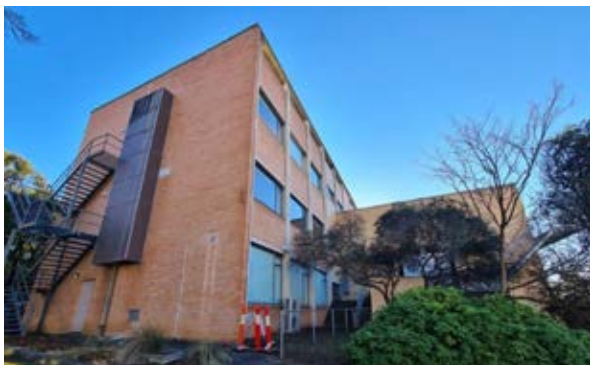
Building 13 – Physics
Southern Wing, Southern Elevation showing the 1967 extension.
Source: Paul Davies Pty Ltd

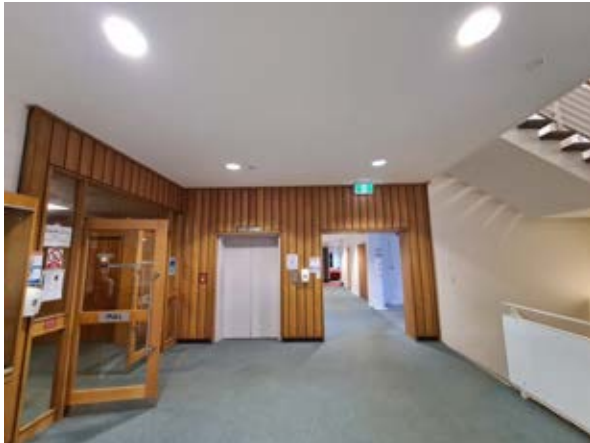
Building 13 – Physics
Timber panelling to the main internal foyer
Source: Paul Davies Pty Ltd

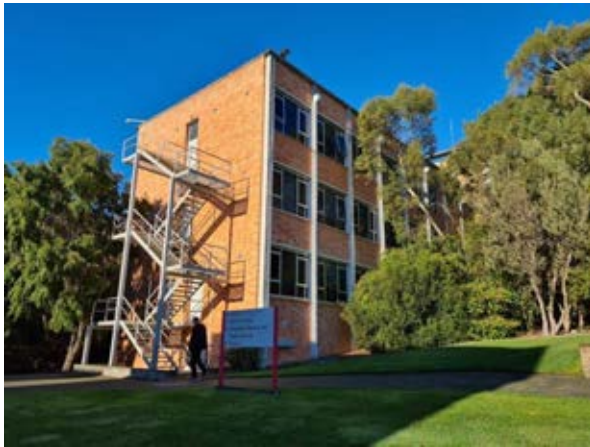
<p>balustrade is more modest than other examples seen on the campus (e.g. the Psychology/Arts Building).</p> <p>Floor levels do not align with the adjoining building resulting in a clumsy arrangement of ramps and stairs to gain access.</p>
Significance	<p>The building is not significant.</p>
Key Elements	<p>-</p>
Condition	<p>The building appears to be in good overall condition, however a detailed inspection was not conducted.</p>

Building 14 – Mathematics
Northern-western corner, showing the external steel fire stair.
Source: Paul Davies Pty Ltd

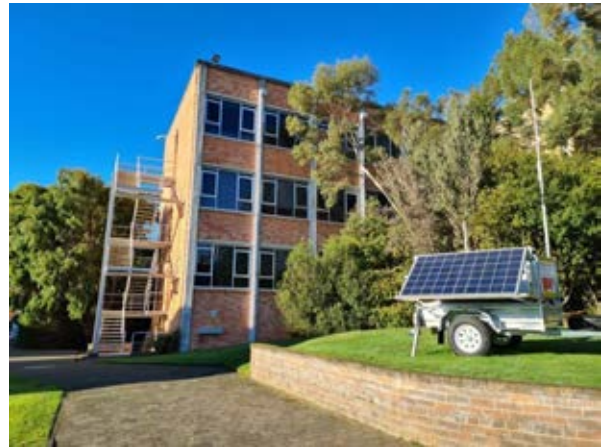
Building 14 - Mathematics
Western façade
Source: Paul Davies Pty Ltd

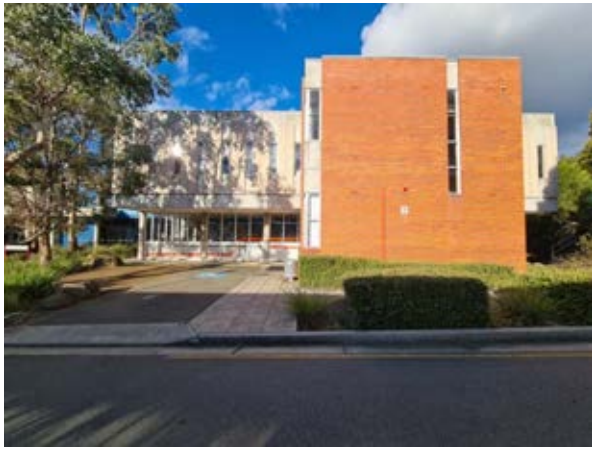
Building 16 – Tasmanian Institute of Agriculture

The building appears to be in good overall condition, however a detailed inspection was not conducted.

Western Elevation

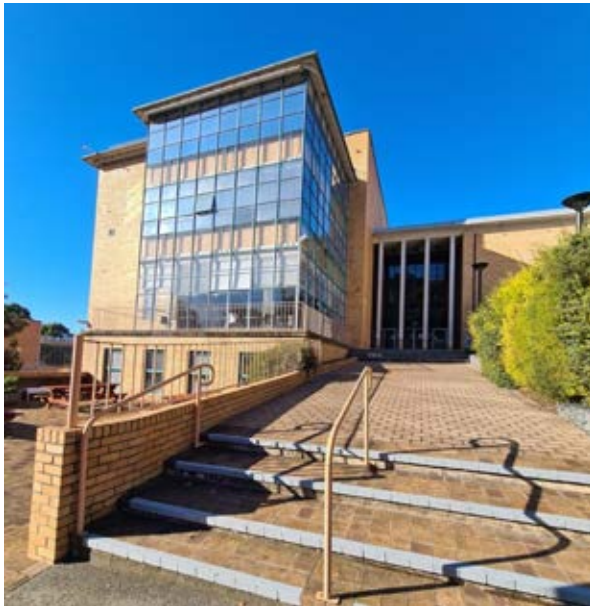
The building appears in very good overall condition.

Building 17 - Chemistry, Central Science Laboratory
Western façade – Main Entrance (Dobson Road)
Source: Paul Davies Pty Ltd

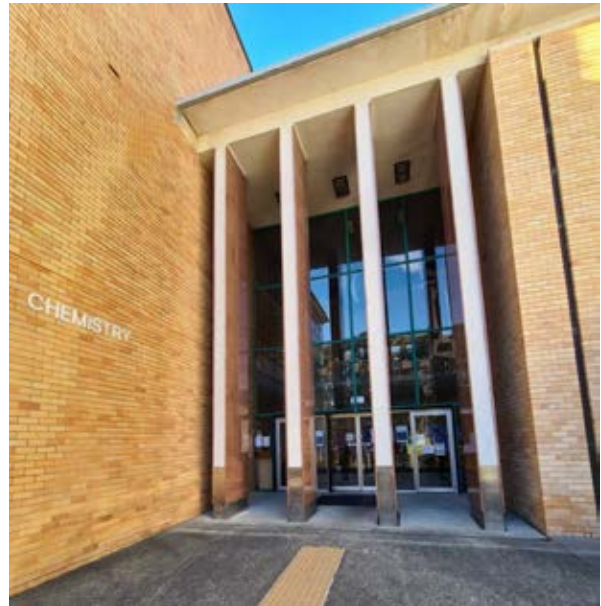
Building 17 - Chemistry, Central Science Laboratory
Detail of the double height main entrance foyer
(Dobson Road)
Source: Paul Davies Pty Ltd

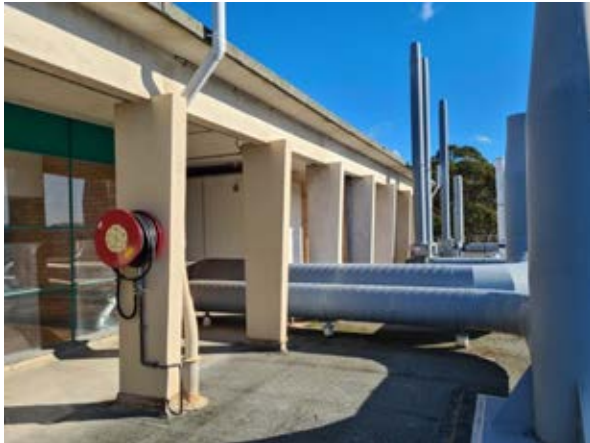
Building 17 - Chemistry, Central Science Laboratory
Detail of the tapered rectangular columns on the rooftop
Source: Paul Davies Pty Ltd

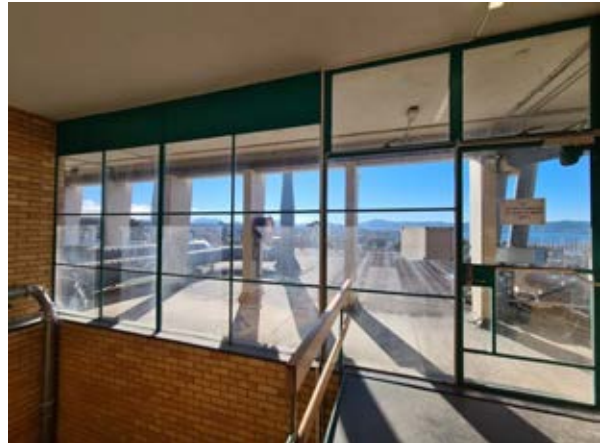
Building 17 - Chemistry, Central Science Laboratory
View of the steel curtain glazing to the rooftop
Source: Paul Davies Pty Ltd

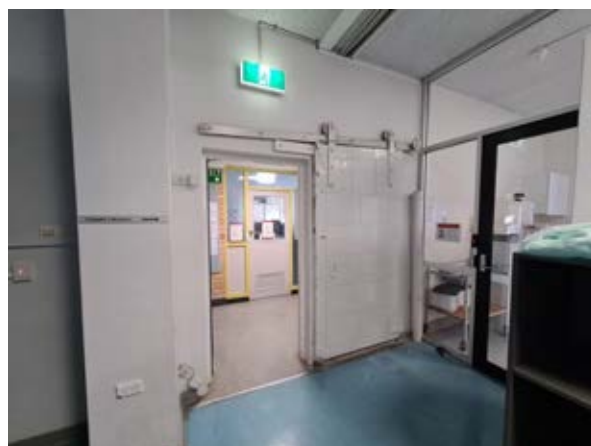
Building 17 - Chemistry, Central Science Laboratory
Detail of original steel sliding fire doors
Source: Paul Davies Pty Ltd

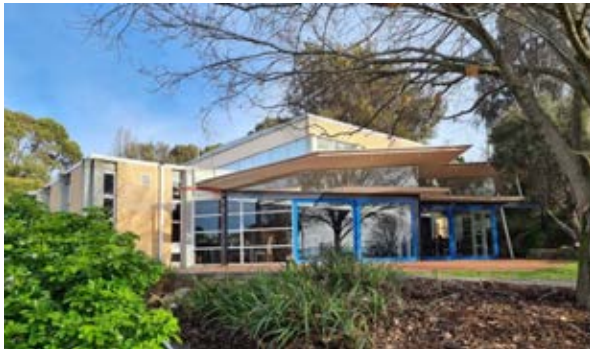
The building appears to be in fair overall condition, however a detailed inspection was not conducted.

Building 18 – University Club
North-eastern façade (main entrance)
Source: Paul Davies Pty Ltd

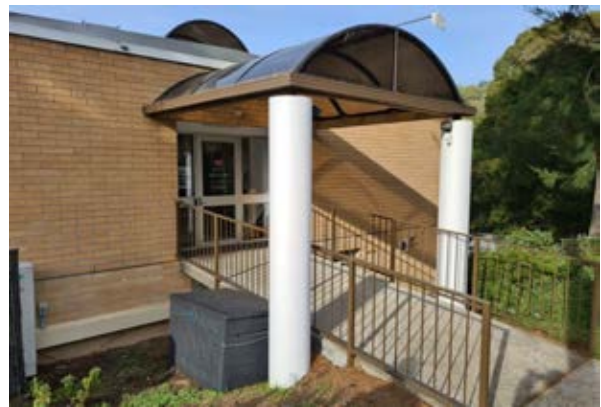
Building 18 – University Club
1986 first floor addition, north-western facade, rear entrance (Alexander Street)
Source: Paul Davies Pty Ltd

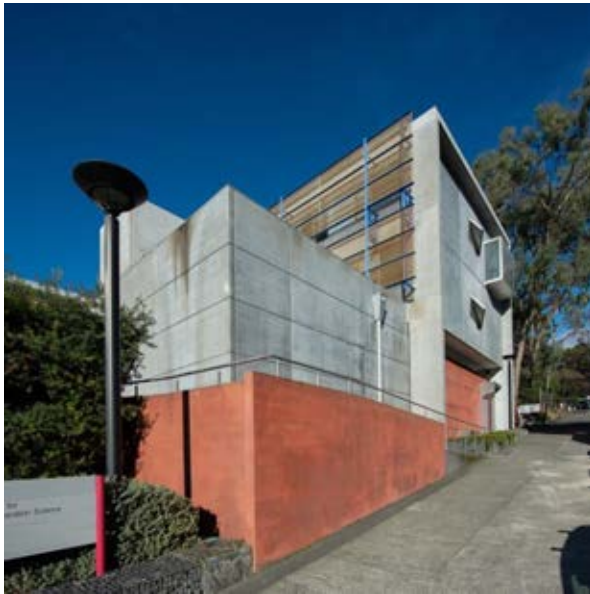
Condition	The building appears to be in good overall condition, however a detailed inspection was not conducted.
-----------	--

Building 20 - Pharmacy
Western façade facing Dobson Road
Source: Paul Davies Pty Ltd

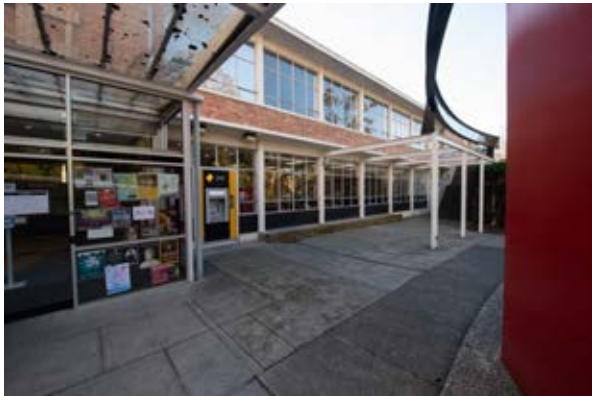
The building appears to be in fair overall condition, however a detailed inspection was not conducted.

Building 21 – Tasmania University Union
Eastern Façade – Main Entrance facing Dobson Road
Source: Paul Davies Pty Ltd

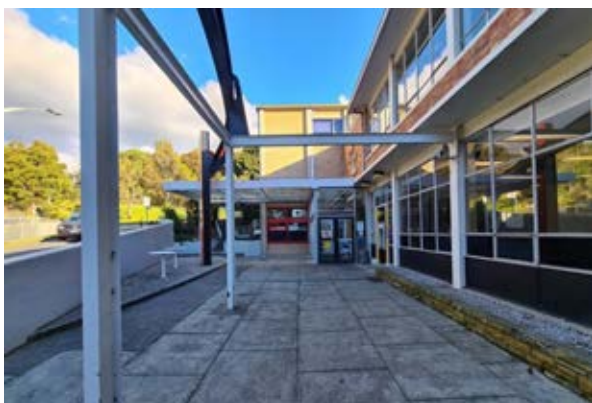
Building 21 – Tasmania University Union
Eastern Façade – Note decorative brick motif above entrance canopy
Source: Paul Davies Pty Ltd

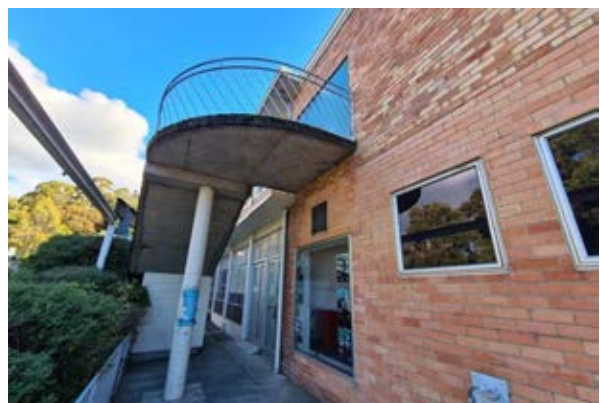
Building 21 – Tasmania University Union
Eastern Façade – with post-modern alterations
Source: Paul Davies Pty Ltd

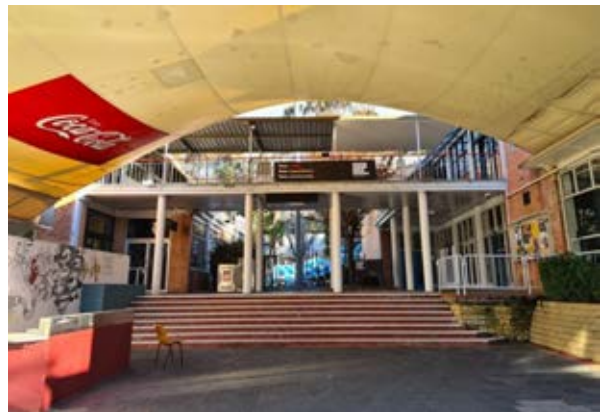
Building 21 – Tasmania University Union
External stair and ramp to the northern wing
Source: Paul Davies Pty Ltd

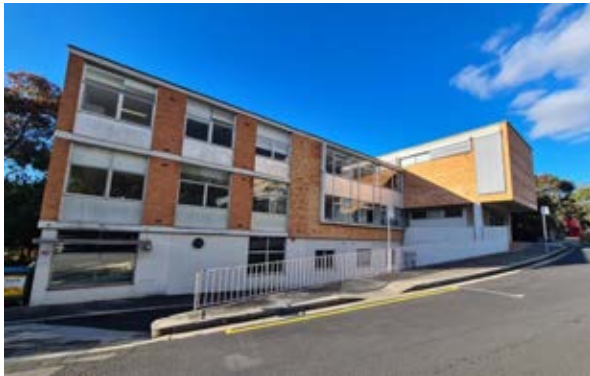
The building appears to be in fair overall condition, however a detailed inspection was not conducted.

Building 22 – Administration Building
Southern Façade facing Dobson Road
Source: Paul Davies Pty Ltd

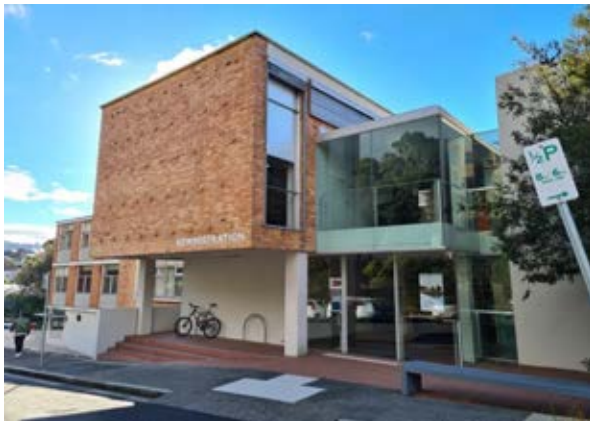
Building 22 – Administration Building
First floor cantilever over main entrance
Source: Paul Davies Pty Ltd

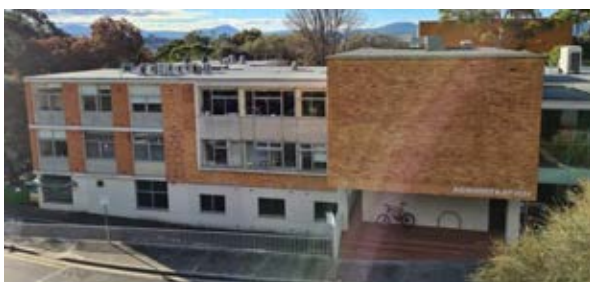
Building 22 – Administration Building
Eastern elevation and bridge to the University Centre
Source: Paul Davies Pty Ltd

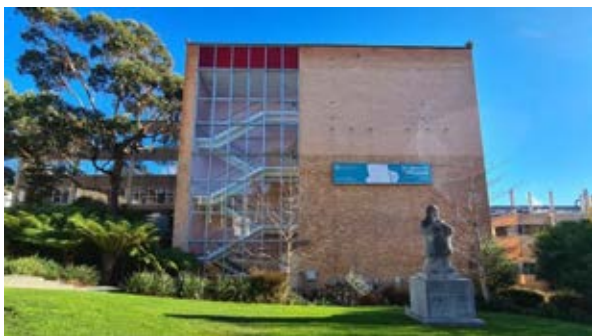
Building 23 – Library, Morris Miller
Eastern elevation of the eastern wing, note glazed curtain wall to the stair circulation
Source: Paul Davies Pty Ltd

The east elevation of the northern wing also features a similar glazed curtain wall detail with low-height blonde face brick walls visible through the curtain wall however the curtain wall is broken up into a smaller grid to suit the two-storey scale of the wing.

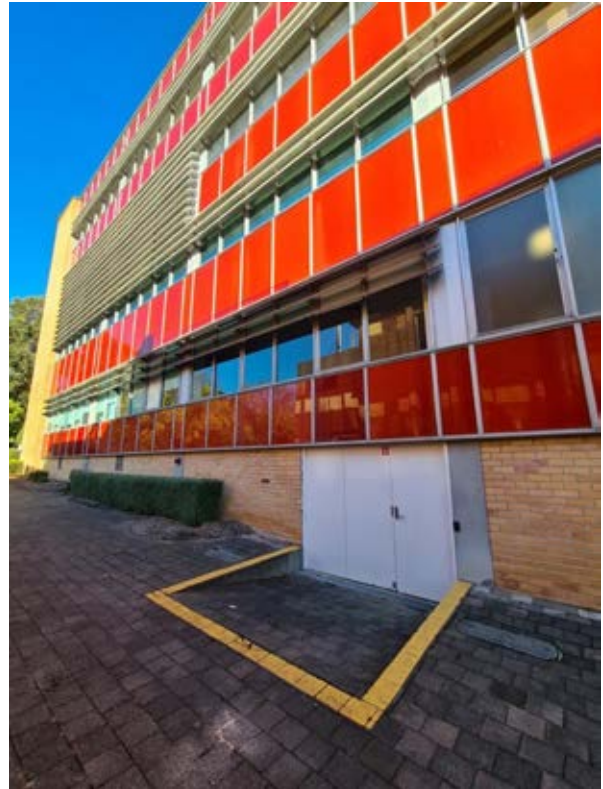
Building 23 – Library, Morris Miller
Detail of the coloured glass curtain wall to the northern facade
Source: Paul Davies Pty Ltd

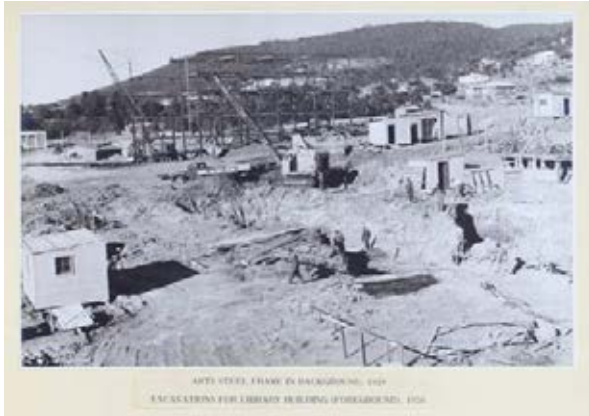
Building 23 – Library, Morris Miller

Excavation for Library

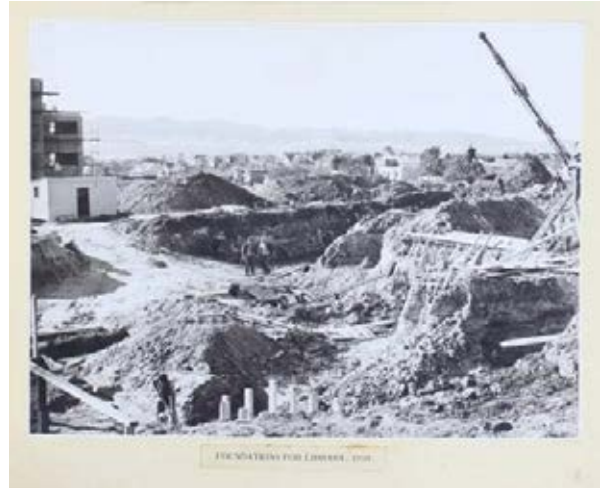
Building 23 – Library, Morris Miller

Foundations for Library

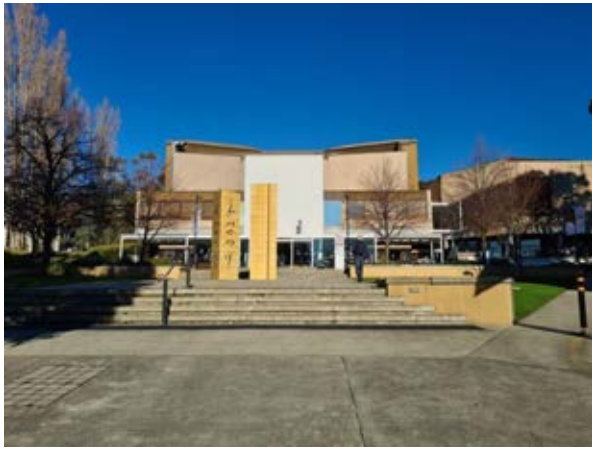
Building 25 – University Centre

Interior Form	<p>The interior comprises a range of spaces including theatres, galleries and a museum and at the lower level the main campus café. The spaces are functional.</p> <p>The main theatre contains a fine pipe organ.</p>
Significance	<p>The building has had various additions and changes and was built in a style that appears to be at odds with the character of the campus.</p> <p>The building has no heritage significance.</p>
Key Elements	-
Condition	<p>The building appears to be in good overall condition, however a detailed inspection was not conducted.</p>

Northern facade

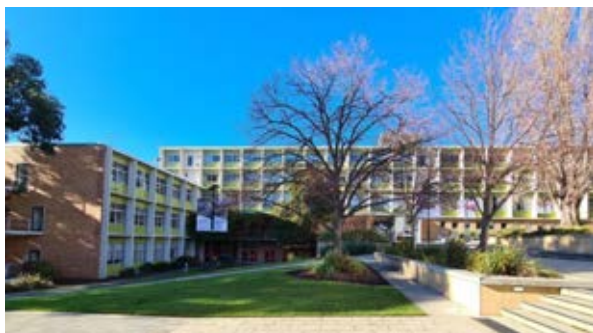
The building appears to be in good overall condition, however a detailed inspection was not conducted.

Building 26 – Psychology, Social Sciences
Western façade
Source: Paul Davies Pty Ltd

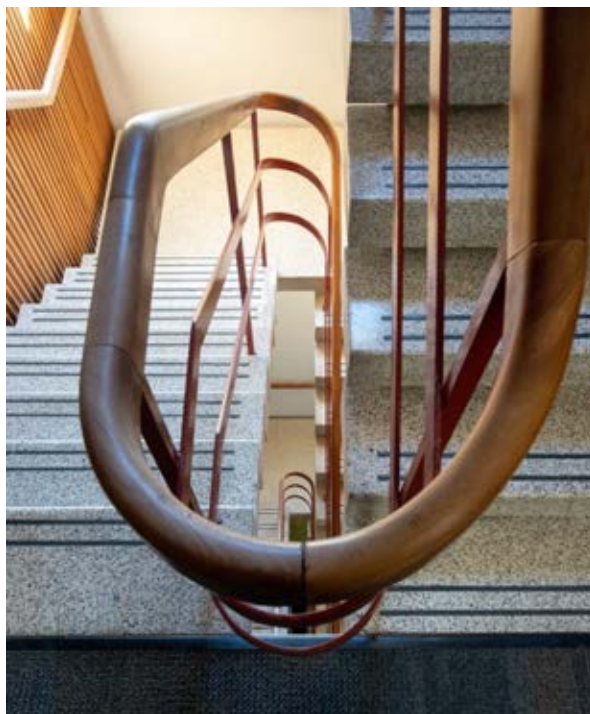
Building 26 – Psychology, Social Sciences
Detail of the timber handrail
Source: Paul Davies Pty Ltd

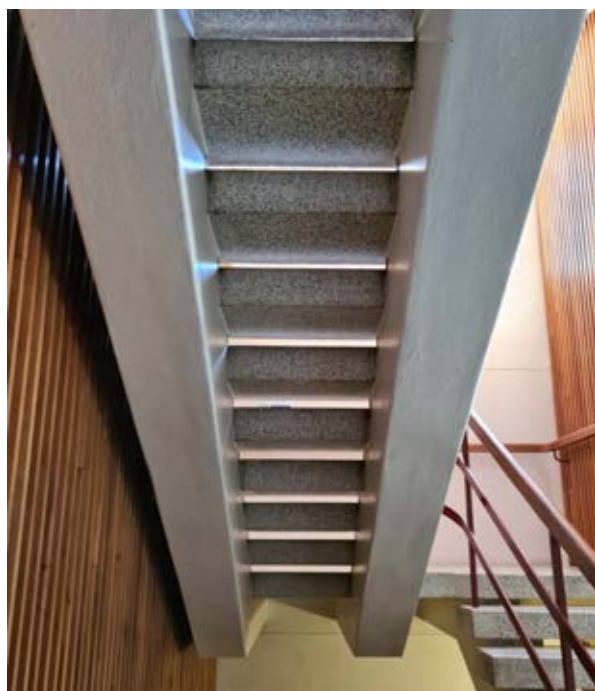
Building 26 – Psychology, Social Sciences
Detail of the underside of the stair
Source: Paul Davies Pty Ltd

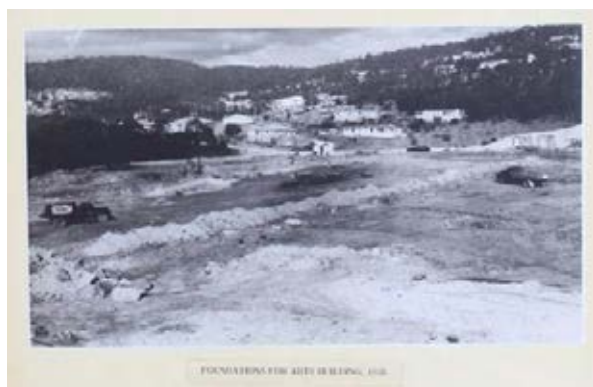
Building 26 – Psychology, Social Sciences (Arts Building)

Foundations for Arts Building

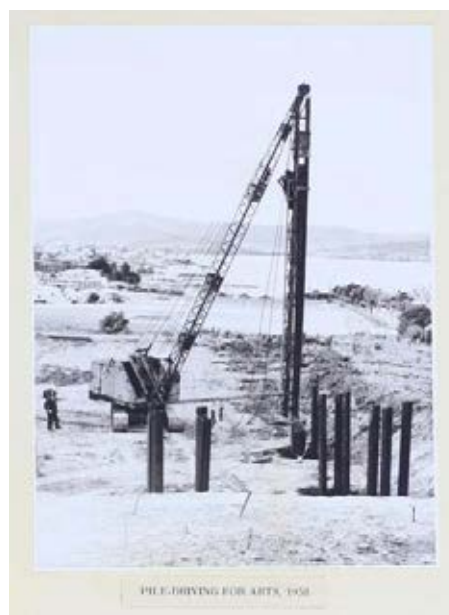
Building 26 – Psychology, Social Sciences (Arts Building)

Pile-Driving for Arts

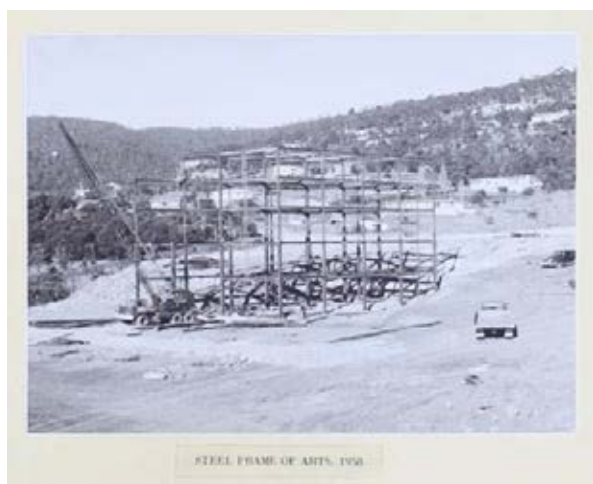
Building 26 – Psychology, Social Sciences (Arts Building)

Steel Frame of Arts
