University of Tasmania Sandy Bay Masterplan

Conservation Management Plan (Volume 2)

UTAS Sandy Bay Campus
Building Data Sheets
Volume 2

September 2021

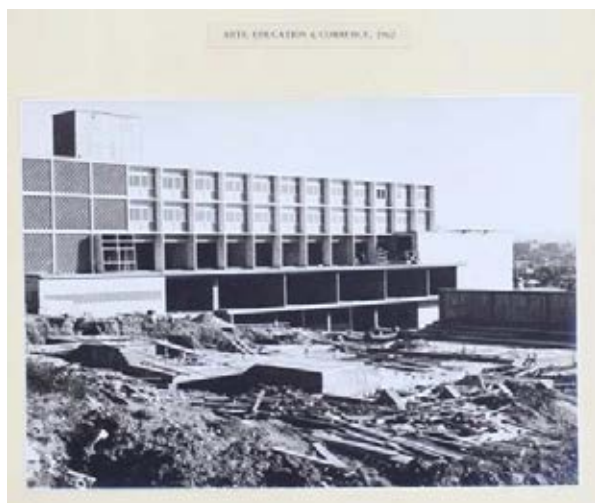
Building 26 – Psychology, Social Sciences (Arts Building)
1962 black and white print
Eastern façade, concrete slabs for the Arts Theatre are shown in the foreground
Source: University of Tasmania, Collection UT460 – Pictorial History of Sandy Bay Campus Buildings; Item 22

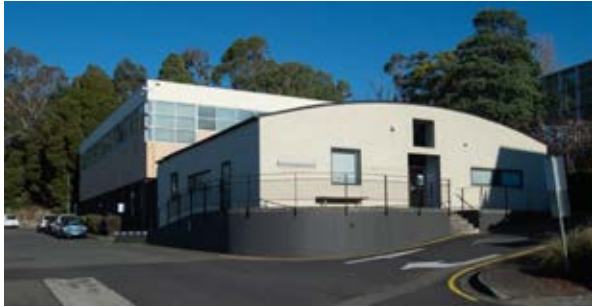
<p>A single storey northern extension was designed in 1990 and is square in plan containing a teaching room, lecture room and offices. This building reads as a separate form to the earlier building and has a separate curved steel roof.</p>
Interior Form	<p>Interior not accessible during site inspection</p>
Significance	<p>The building, as it is now found with its various additions and changes sits on the fringe of the central campus and has no direct part in the layout of the central campus area. As first built and as later changed the building does not display any characteristics that mark it as a building of importance</p> <p>The building has no heritage significance.</p>
Key Elements	<p>-</p>
Condition	<p>The building appears to be in good overall condition, however a detailed inspection was not conducted.</p>

Building 28 – Psychology Research Centre
North-eastern corner with the 1990 extension in the foreground
Source: Paul Davies Pty Ltd

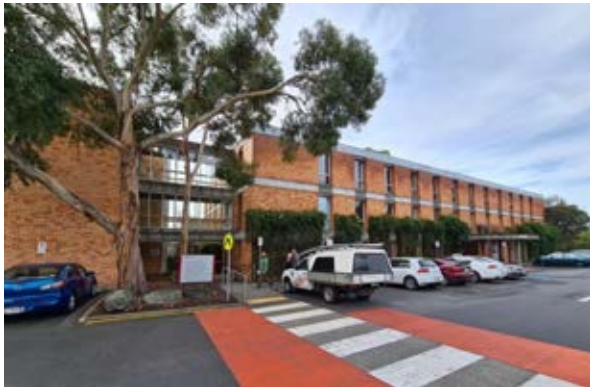
<p>the floorplate. The interior finishes include concrete block walls creating a quite utilitarian appearance.</p> <p>The lower ground floor contains storage to the north-eastern corner of the building.</p> <p>The interiors do not exhibit any details of interest.</p>
Significance	<p>The building is interesting in relation to the overall evolution of campus buildings, demonstrating a shift away from innovation into more standard forms of construction. It is not an outstanding or innovative building and does not have heritage value.</p>
Key Elements	<p>-</p>
Condition	<p>The building appears to be in good overall condition, however a detailed inspection was not conducted.</p>

Building 29 – Humanities Building
Southern Facade
Source: Paul Davies Pty Ltd

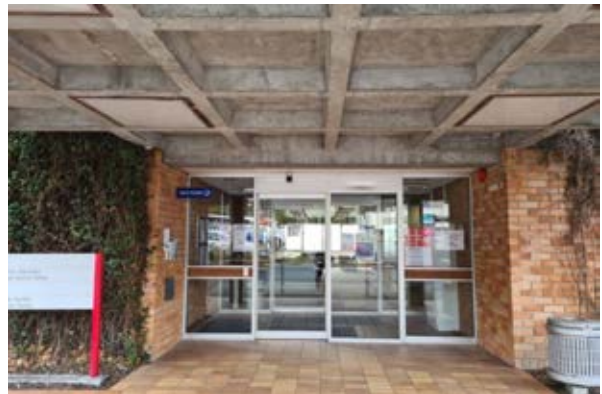
Building 29 – Humanities Building
Detail of cast concrete ceiling to the entrance portico
Source: Paul Davies Pty Ltd

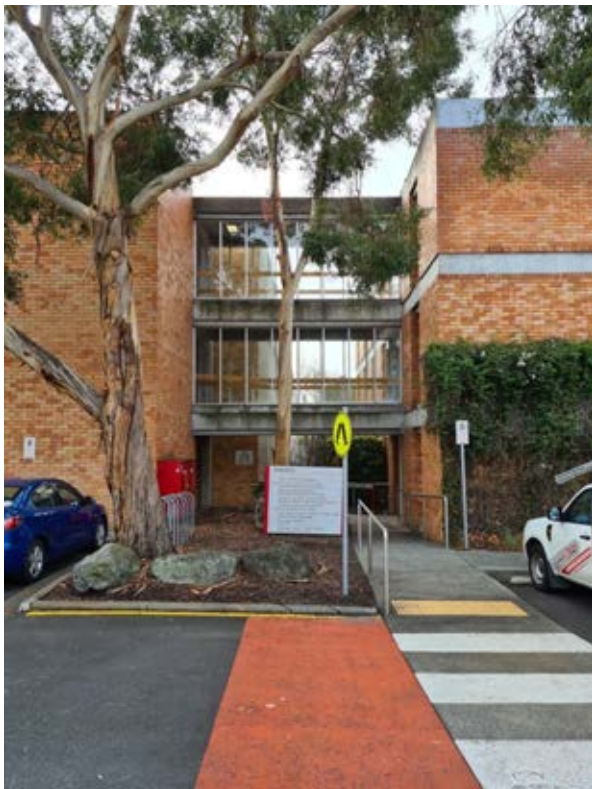
Building 29 – Humanities Building
Glazed link between Humanities (image right) and Psychology (image left) - south elevation
Source: Paul Davies Pty Ltd

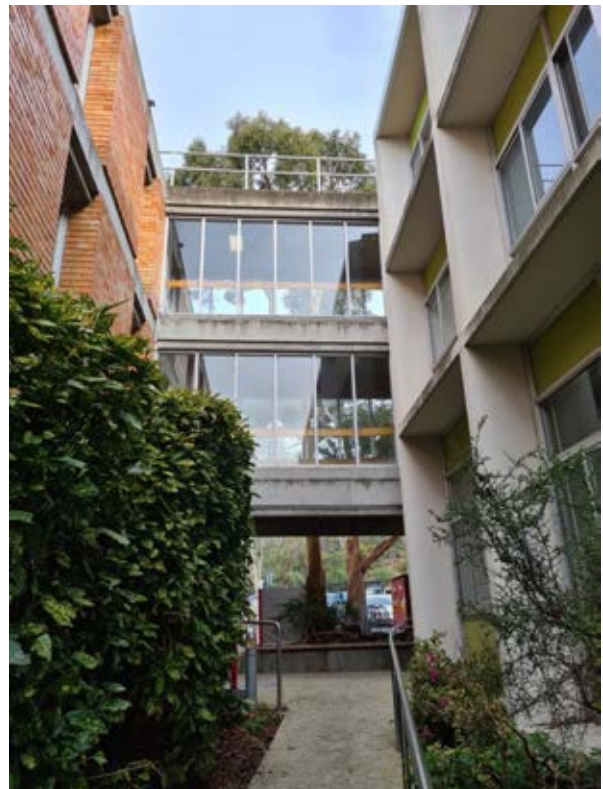
Building 29 – Humanities Building
Glazed link between Humanities (image left) and Psychology (image right) – north elevation
Source: Paul Davies Pty Ltd

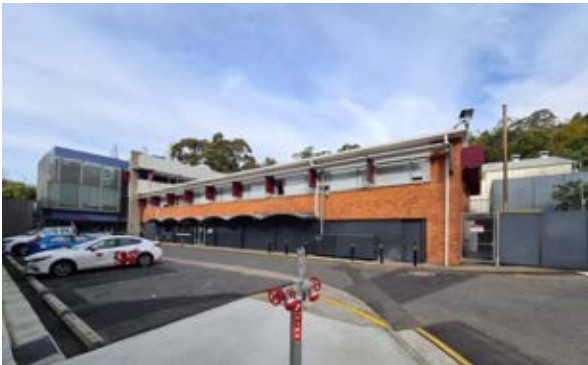
The early form is discernible but is now a minor part of the form of the building created by the 2008 additions to a point where the building has no heritage significance.
Key Elements	-
Condition	The building appears to be in reasonable condition, however an extensive inspection was not conducted.

Building 32 – Corporate Services Building
Northern façade
Source: Paul Davies Pty Ltd

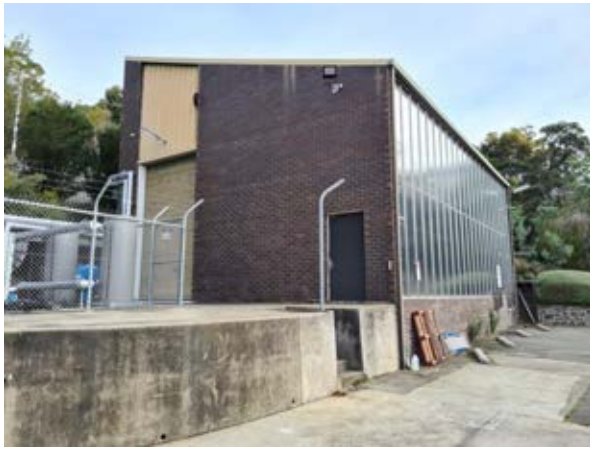
Exterior Form	The boiler house is a rectangular single storey building with a steeply pitched skillion roof which follows the approximate slope of the site. The east, west and south facades feature 'heather brown' extruded face bricks. The northern façade consists of a full length and height curtain glass wall constructed from ¼" wire cast glass in 'Aluminex' glazing bars.
Interior Form	Interior not accessible during site inspection.
Significance	The building is not of heritage significance.
Key Elements	-
Condition	The building appears to be in fair overall condition, however a detailed inspection was not conducted.

Building 32a – Boiler House
Eastern elevation
Source: Paul Davies Pty Ltd

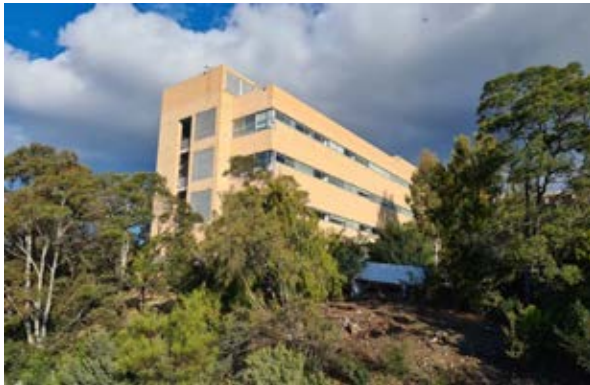
The building appears to be in fair overall condition, however a detailed inspection was not conducted.

Building 34 – Life Sciences Building
North-western corner of the 1986-87 northern wing
Source: Paul Davies Pty Ltd

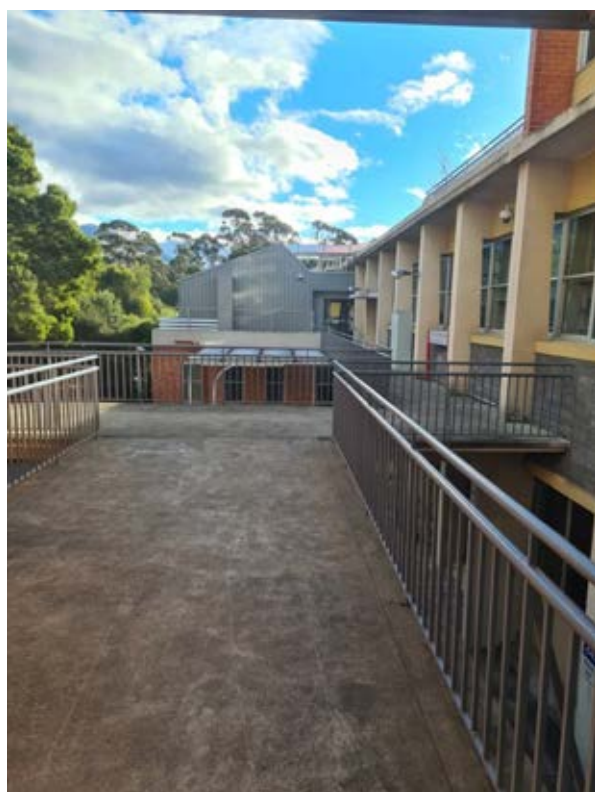
Building 34 – Life Sciences Building
Elevated concrete walkway to the south side of the original central wing
Source: Paul Davies Pty Ltd

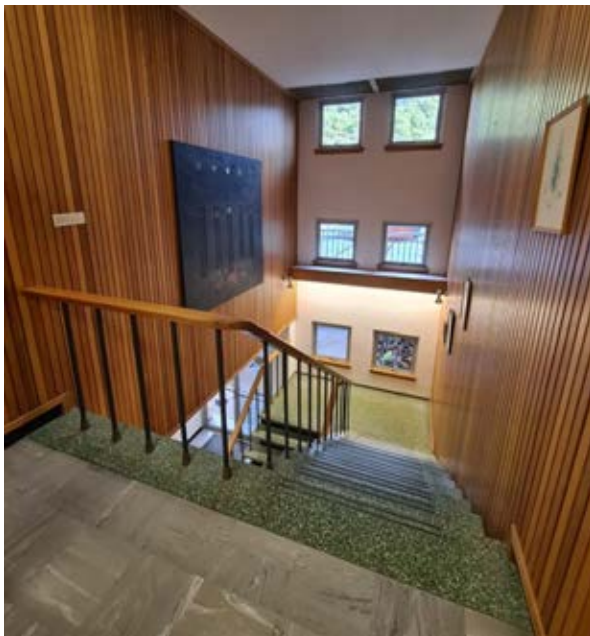
Building 34 – Life Sciences Building
Central stair to the main entrance foyer of the original central wing, detail of the timber wall panelling
Source: Paul Davies Pty Ltd

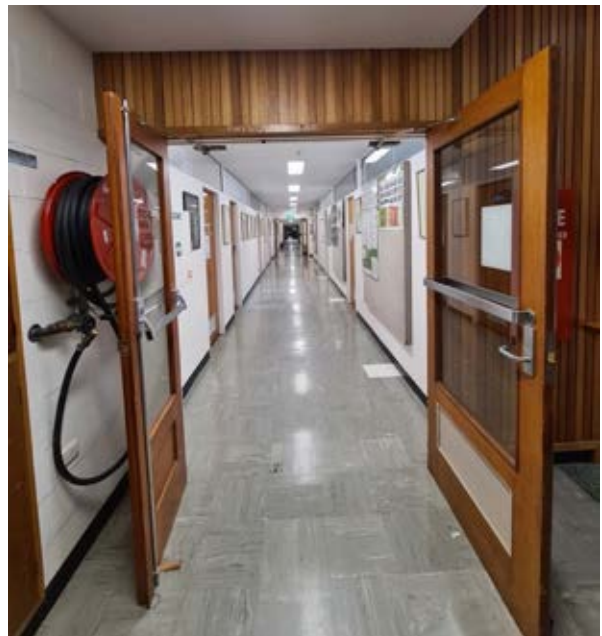
Building 34 – Life Sciences Building
Typical central corridor of the original central wing with original timber joinery
Source: Paul Davies Pty Ltd

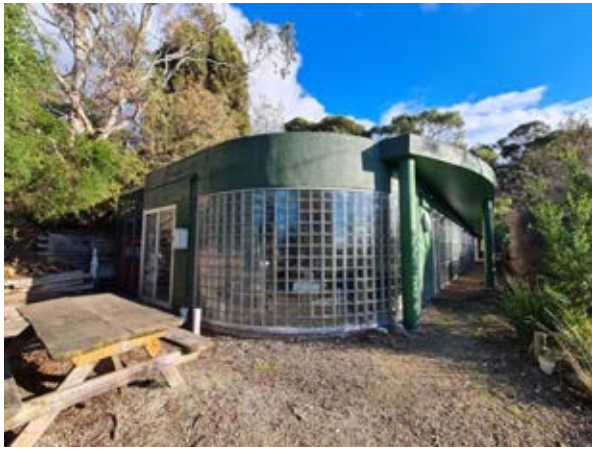
Interior Form	Interior not accessible during site inspection	
Significance	<p>The building is an interesting design for the campus and unrelated to any other building form on the site. Possibly driven by the desire to manage thermal conditions, burying the building was an innovative approach.</p> <p>The building is not of heritage significance.</p>	
Key Elements	-	
Condition	The building appears to be in reasonable condition, however an extensive inspection was not conducted.

Building 36 – Herbarium, Tasmanian
North-eastern corner
Source: Paul Davies Pty Ltd

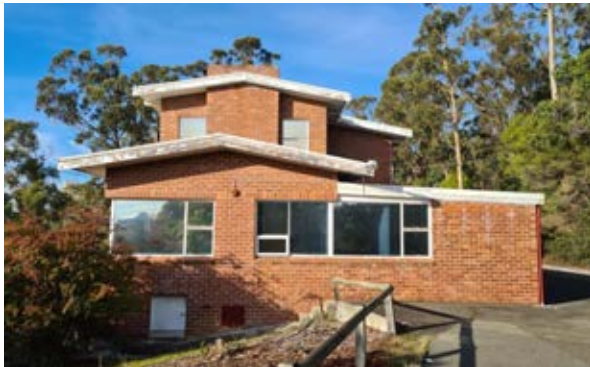
Interior Form	The interior has been heavily altered to create office use and while rooms remain from its use as a residence most of the residential fitout has been removed.
Significance	The building has some significance as an early element of the campus development as a bespoke VC residence, however the numerous changes to the building and use have had a major impact on the integrity and form of the building that has diminished any significance it may have had. The building in its current form has low heritage significance.
Key Elements	-
Condition	The building appears to be in fair overall condition, however a detailed inspection was not conducted.

Building 38 – Research House
North-western facade
Source: Paul Davies Pty Ltd

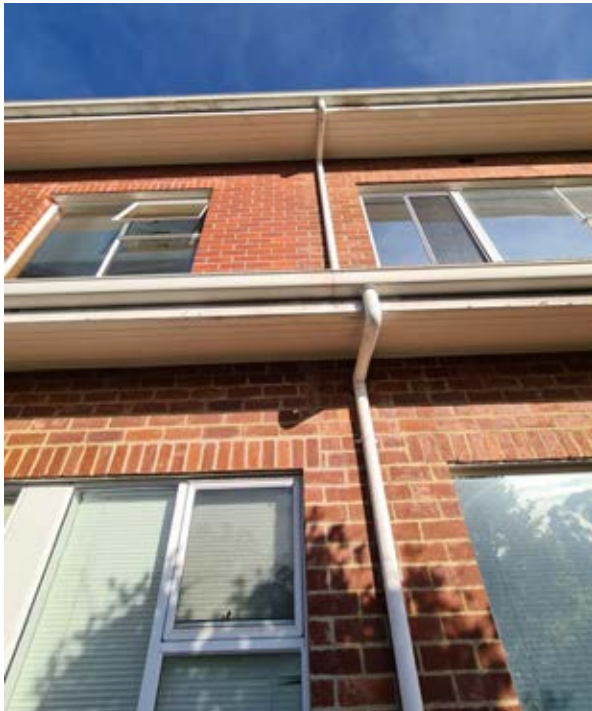
Building 38 – Research House
Evidence of the first floor extension to the east can be seen in the change in brickwork on the first floor and evidence of the former mitred corner to the first floor eaves lining.
Source: Paul Davies Pty Ltd

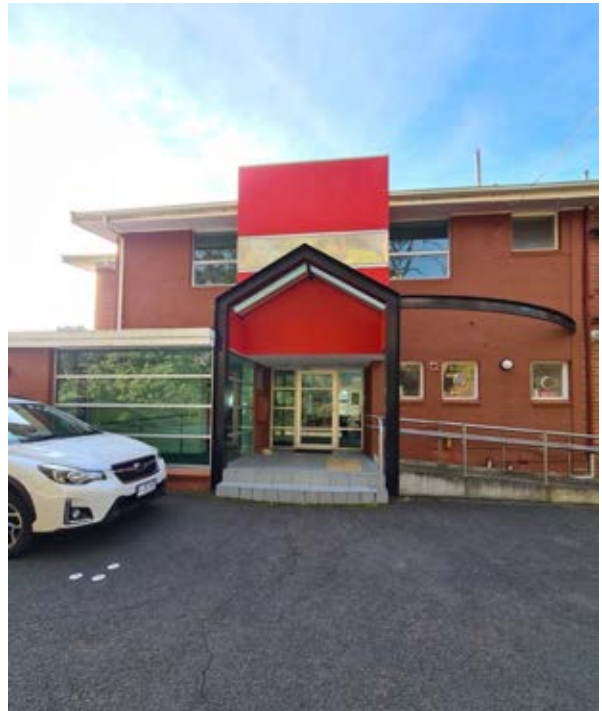
Building 38 – Research House
Postmodern addition to the south-western façade to create a new entrance
Source: Paul Davies Pty Ltd

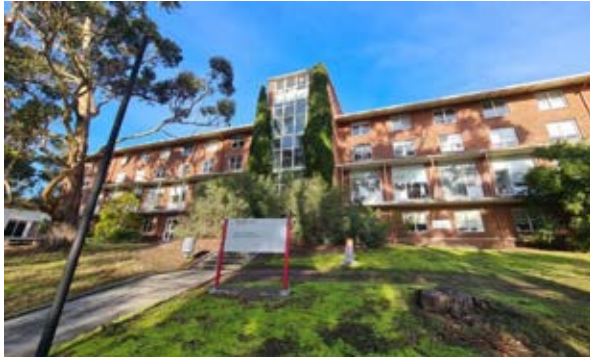
The building appears to be in average overall condition, however a detailed inspection was not conducted.

Building 40 – Hytten Hall
North-eastern façade
Source: Paul Davies Pty Ltd

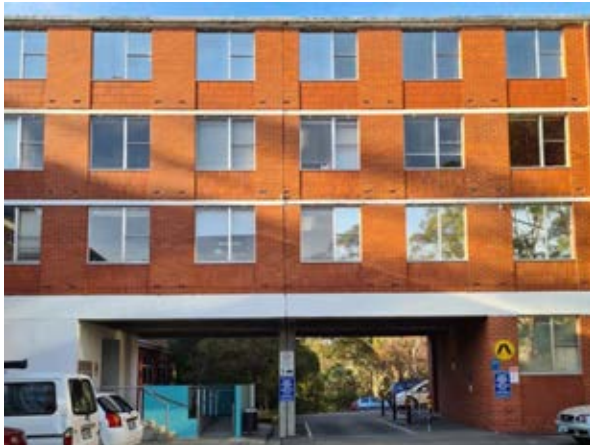
Building 40 – Hytten Hall
Detail of the western façade of the southern extension wing. The extension is evident in the brickwork and the double column.
Source: Paul Davies Pty Ltd

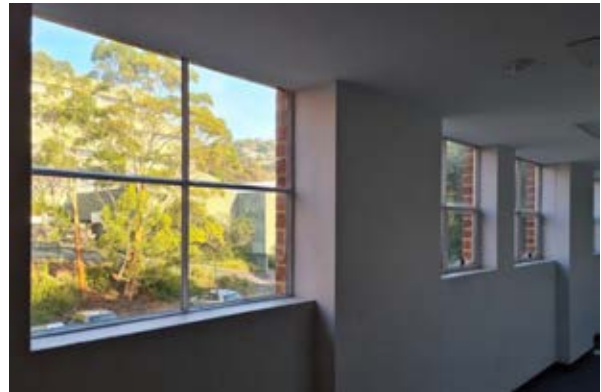
Building 40 – Hytten Hall
Detail of an original steel window to the southern corridor of the original western wing
Source: Paul Davies Pty Ltd

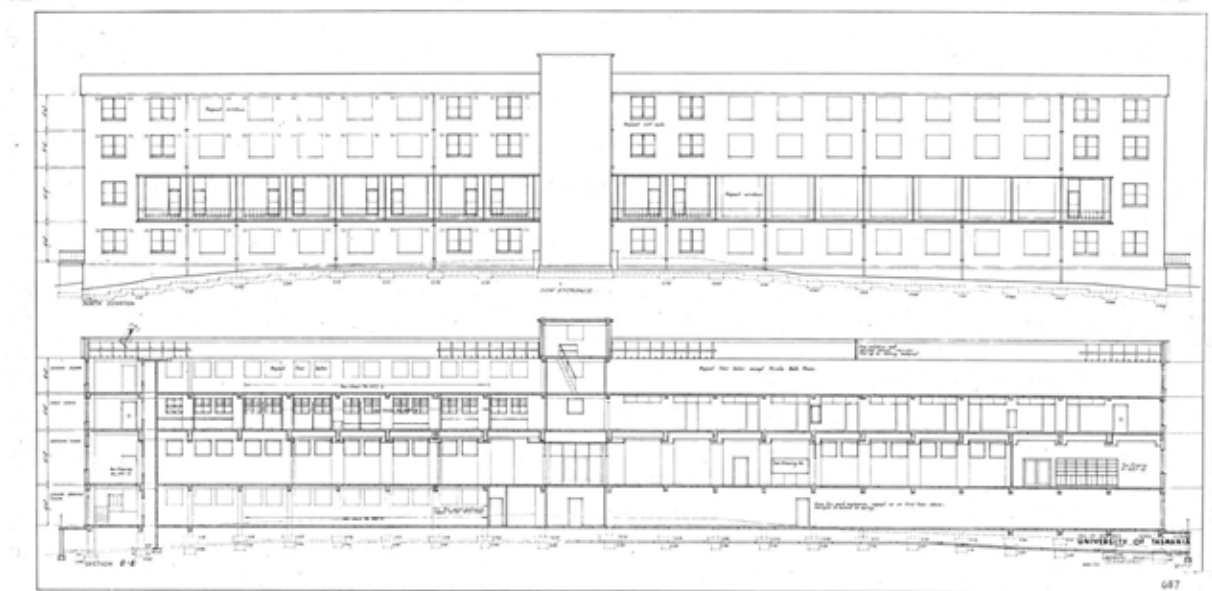
Elevations – Hall of Residence, University of Tasmania. Prepared by John F.D Scarborough, 1952.

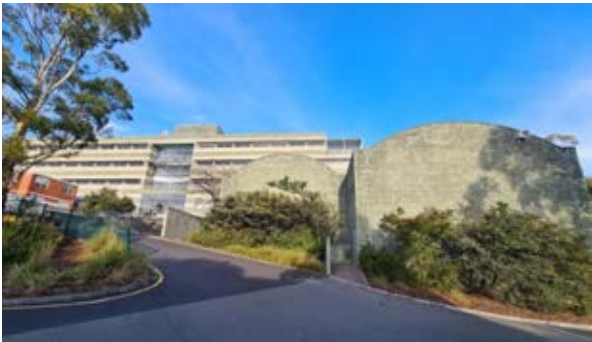
The building appears to be in good overall condition, however a detailed inspection was not conducted.

Building 40a – International Pathway College
North-eastern facade
Source: Paul Davies Pty Ltd

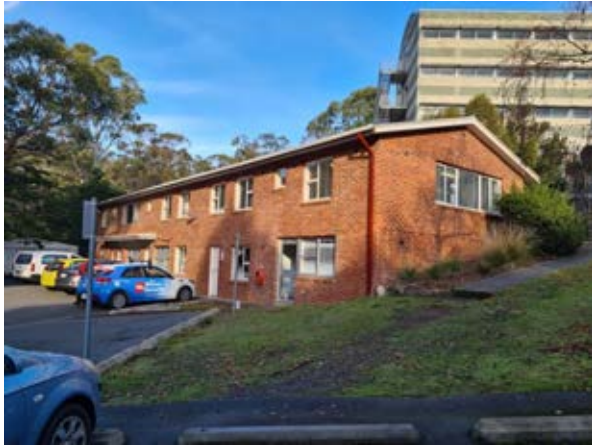
The building appears to be in fair overall condition, however a detailed inspection was not conducted.

Building 40b – Old Commerce Annex
North-eastern corner
Source: Paul Davies Pty Ltd

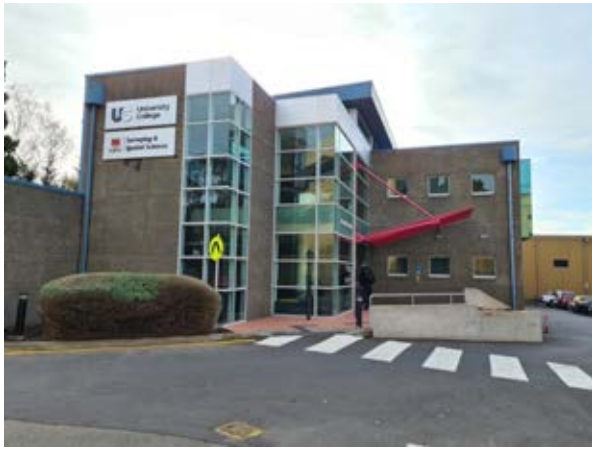
Building 49 – Old IMAS Building

Interior Form	<p>Interior not accessible during site inspection</p>	
Significance	<p>The building does not have heritage significance.</p>	
Key Elements	<p>-</p>	
Condition	<p>The building appears to be in fair overall condition, however a detailed inspection was not conducted.</p>

South-western elevation

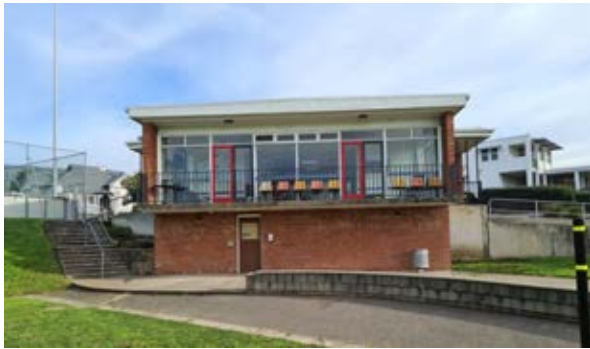
of the building contains two separate change rooms including showers, WCs and locker room facilities.
Interior Form	Interior not accessible during site inspection.
Significance	The building has moderate significance as one of the early buildings on the campus that related to the development of the sports facilities on the lower campus area. The design of the building is modest and it is not an outstanding example of its style from the period. It is representative of the work being designed by Public Works at the time.
Key Elements	-
Condition	The building appears to be in fair overall condition, however a detailed inspection was not conducted.

Building 50 – Rugby Pavilion
Eastern façade (facing playing field)
Source: Paul Davies Pty Ltd

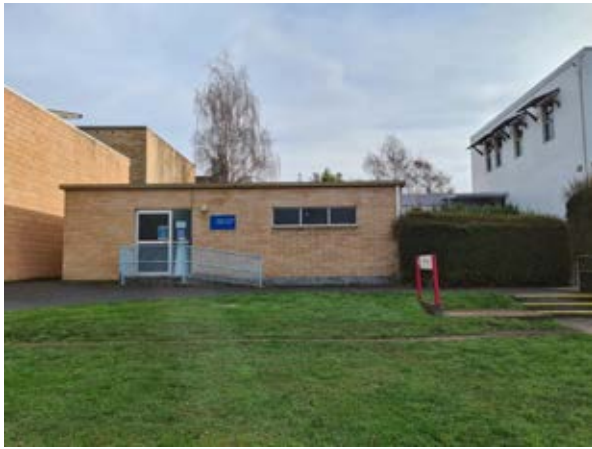
Building 52 – Community Health Clinic

Condition	The building appears to be in fair overall condition, however a detailed inspection was not conducted.
-----------	--

Eastern facade

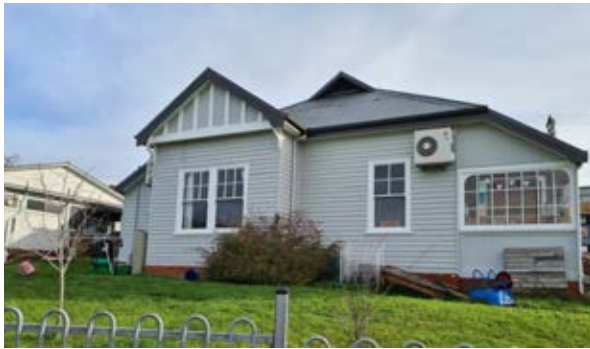
Condition	<p>The building appears to be in good overall condition, however a detailed inspection was not conducted.</p>

Building 53 – Childcare Cottage
South-eastern elevation
Source: Paul Davies Pty Ltd

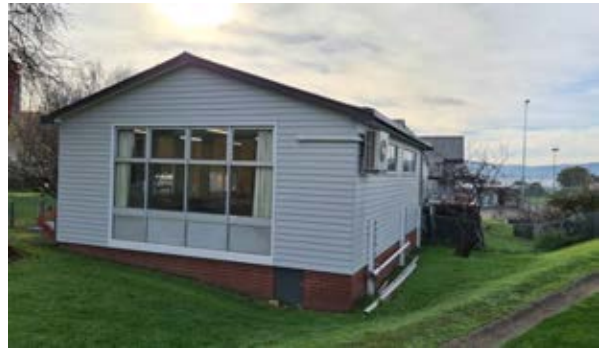
Building 53 – Childcare Cottage
South elevation
Source: Paul Davies Pty Ltd

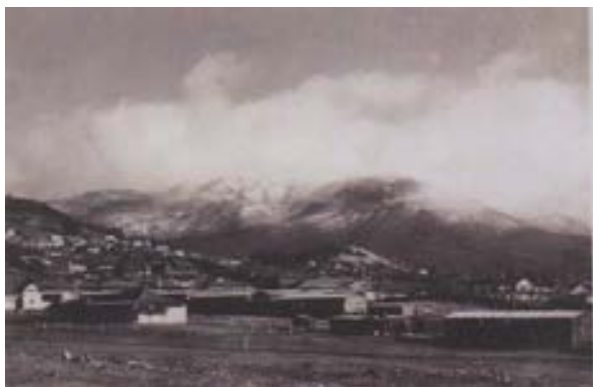
Building 53 – Childcare Cottage

Sandy Bay campus facing Mt Wellington. The cottage can be seen to the lower far left of the image behind the rifle range clubhouse, the building on the far right is the golf course clubhouse.

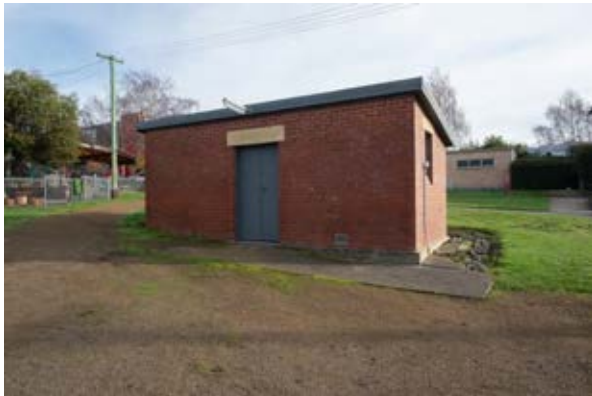
Condition	The building appears to be in good overall condition, however a detailed inspection was not conducted.
------------------	--

Building 53a – Brick Store Room
Eastern elevation
Source: Paul Davies Pty Ltd

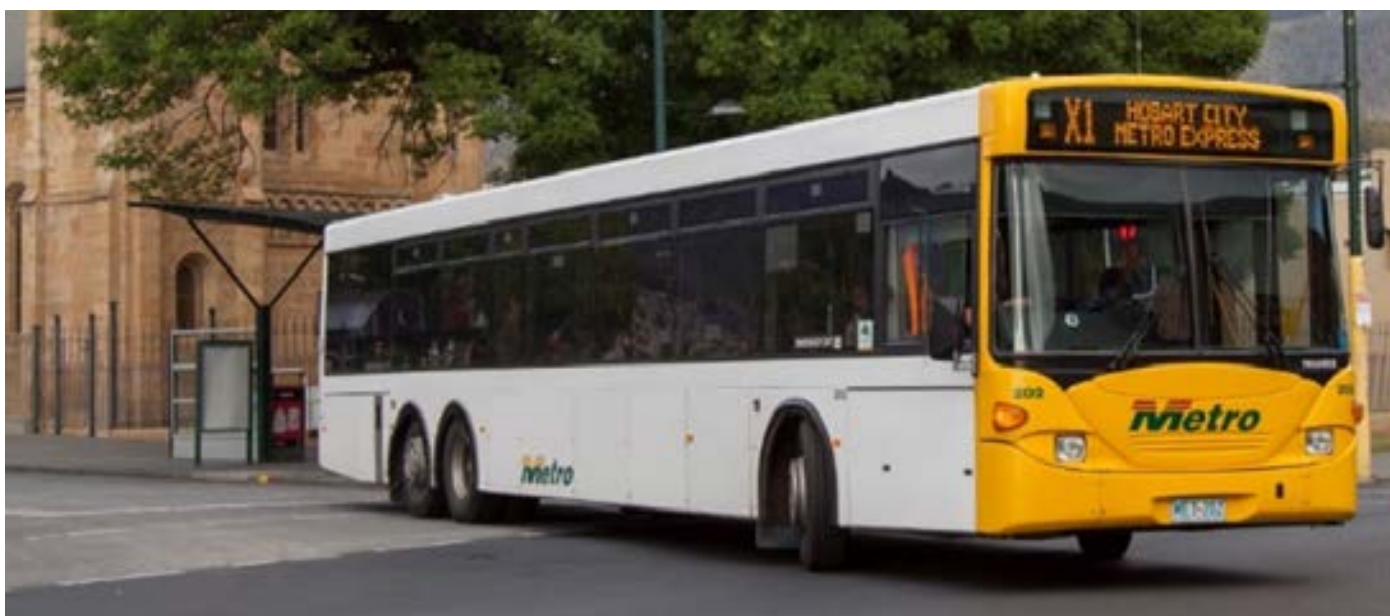
Sandy Bay Campus of the University of Tasmania is one of the best serviced sites by bus in Tasmania. As shown below, it is serviced by routes 402, 427,422, 428, 426, 429 along Sandy Bay Road, by routes 401, 501 and 601 along Churchill Avenue and routes 410, 413, 415, 416, 417, X58, 716 and 718. This is a significant amount of bus infrastructure, however, the competing mode, the private car, has had much more infrastructure (streets, roads and car parks) supply it to take patronage away from the bus. This is important to acknowledge, as car infrastructure is very expensive to supply for both the developer and for the community. The more trips that can be converted to bus trips will make a major difference to the financial sustainability of the development as well as the economic sustainability of the City.

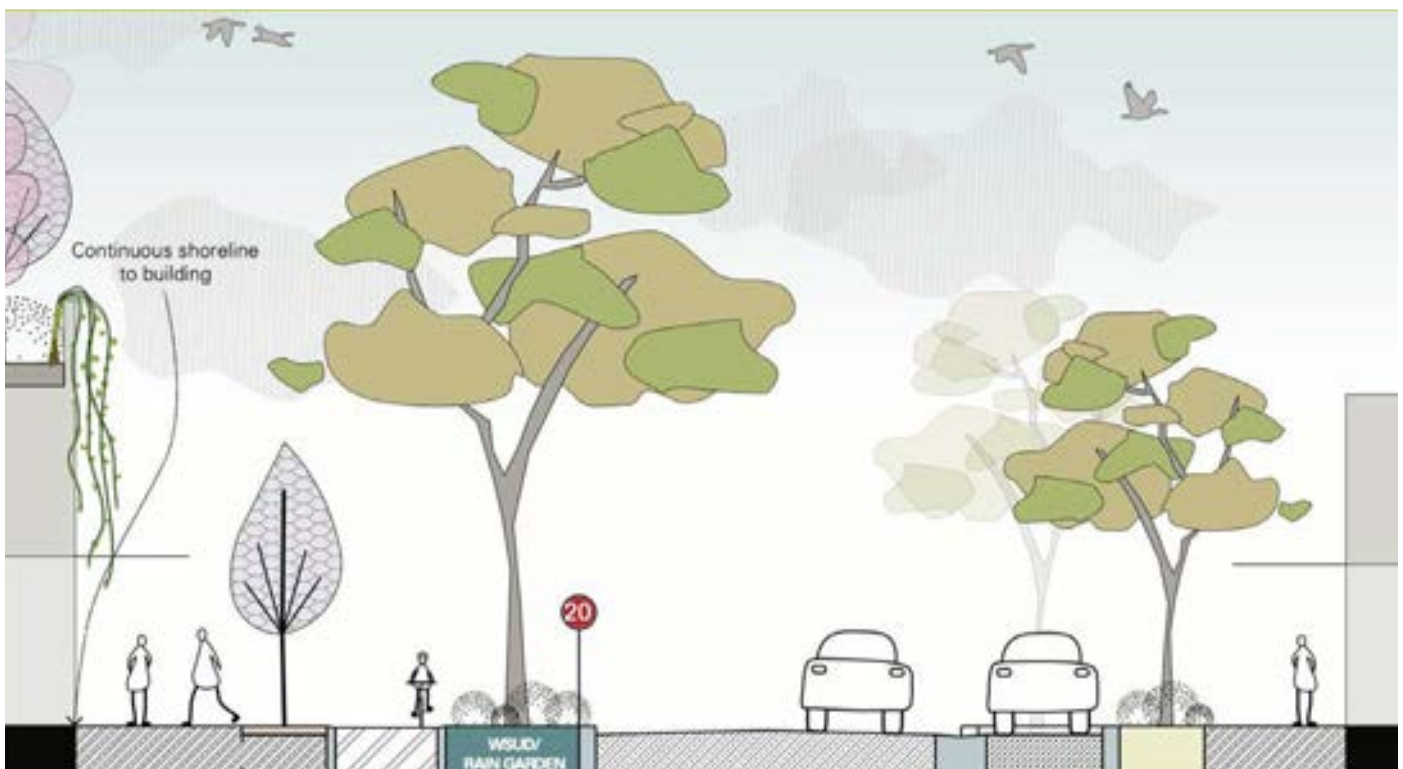
Figure 5 – proposed street cross section (source Playstreet)

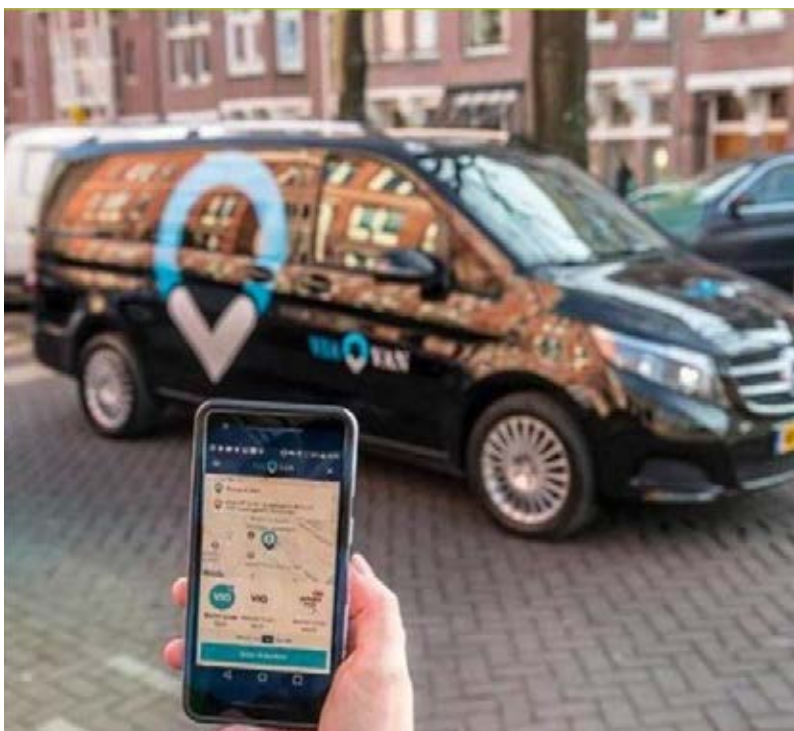
Figure 12 – On-Demand Service Vehicle with App

The on-demand bus can be delivered in a number of ways. UPPL could be the operator, Metro could be the operator, or another commercial entity. The services run on demand within a specified area. It would take patrons from anywhere in the site to common destinations (bus superstops, sporting grounds, shopping facilities etc). They would service the immediately surrounding suburbs as well

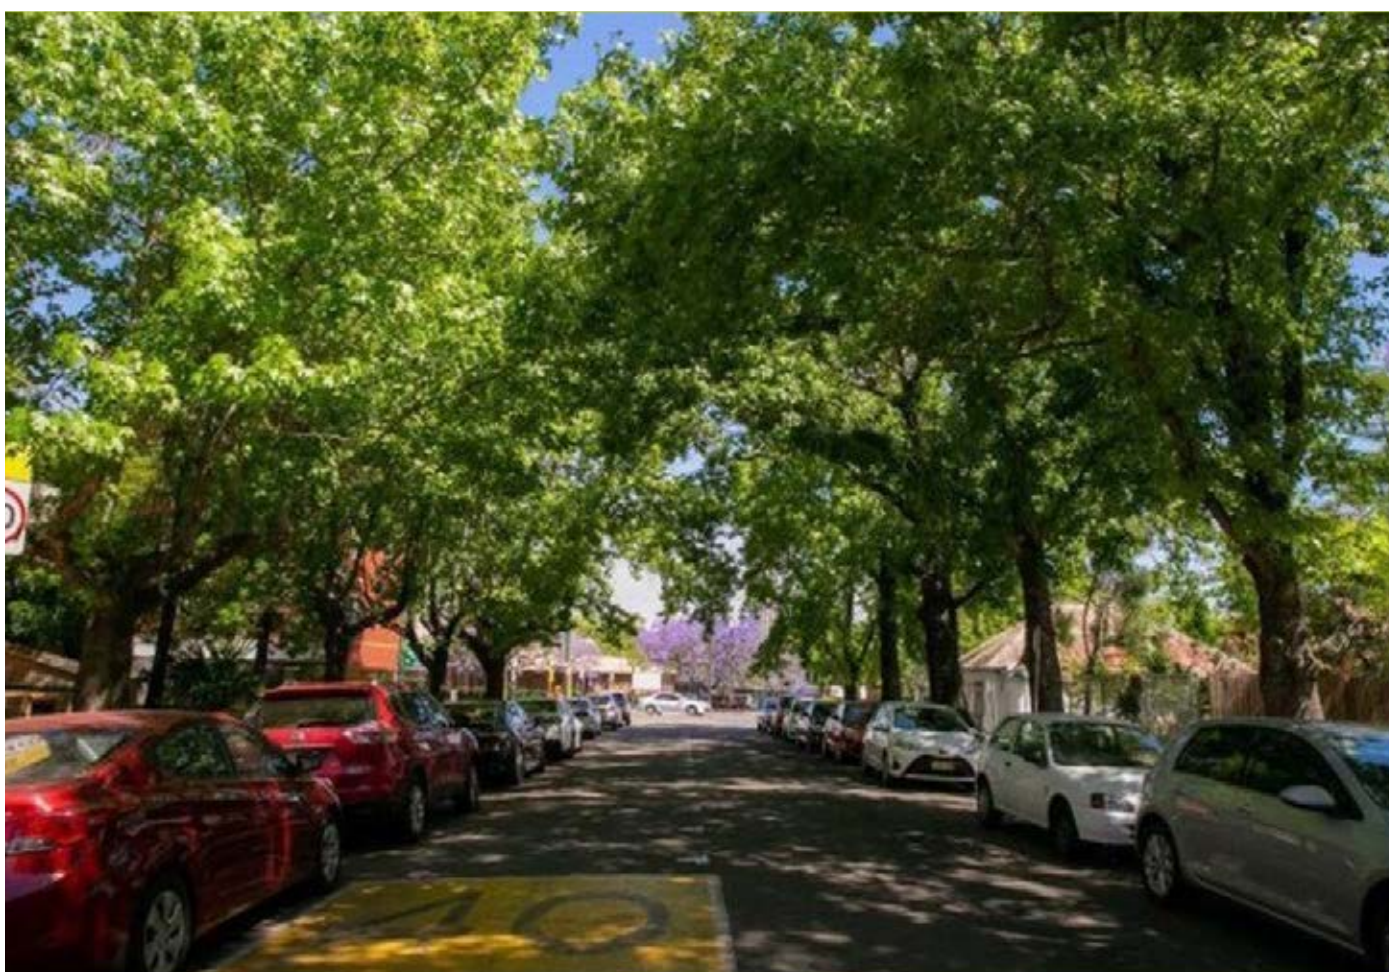
Figure 13 – Narrow Tree Lined Street

Streets don't have to be wide to clean, green and safe, and tree lining streets approaching the site will greatly improve the appeal of the site to pedestrians as shown in Figure 13.

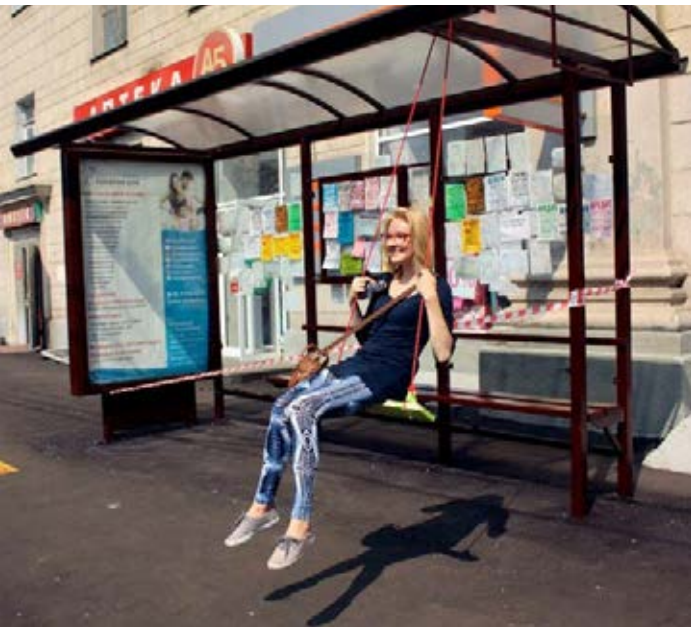
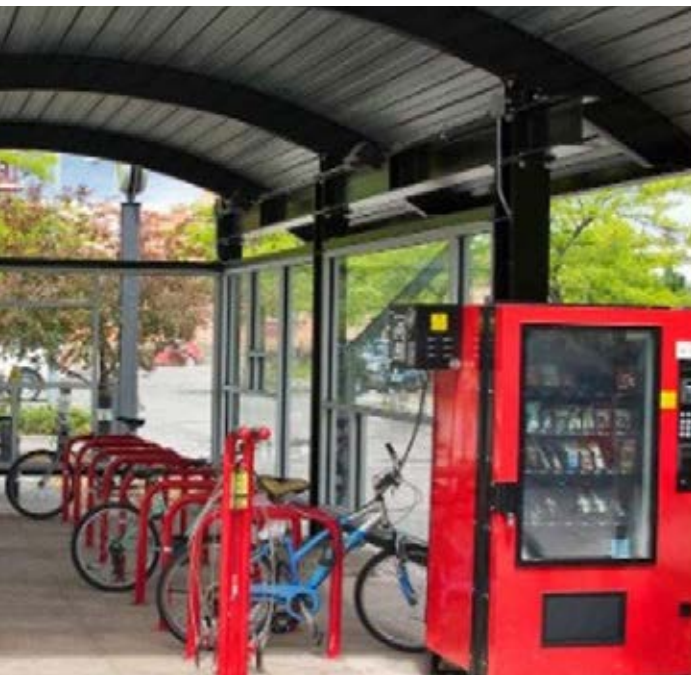
Figure 14 – Bus Superstops

- The stop would be serviced internally and externally by an on-demand bus service;
- This superstop should also incorporate lockable bike storage and a pick up for shared electric bikes.

- Superstops could contribute significantly to the urban vitality of the site.

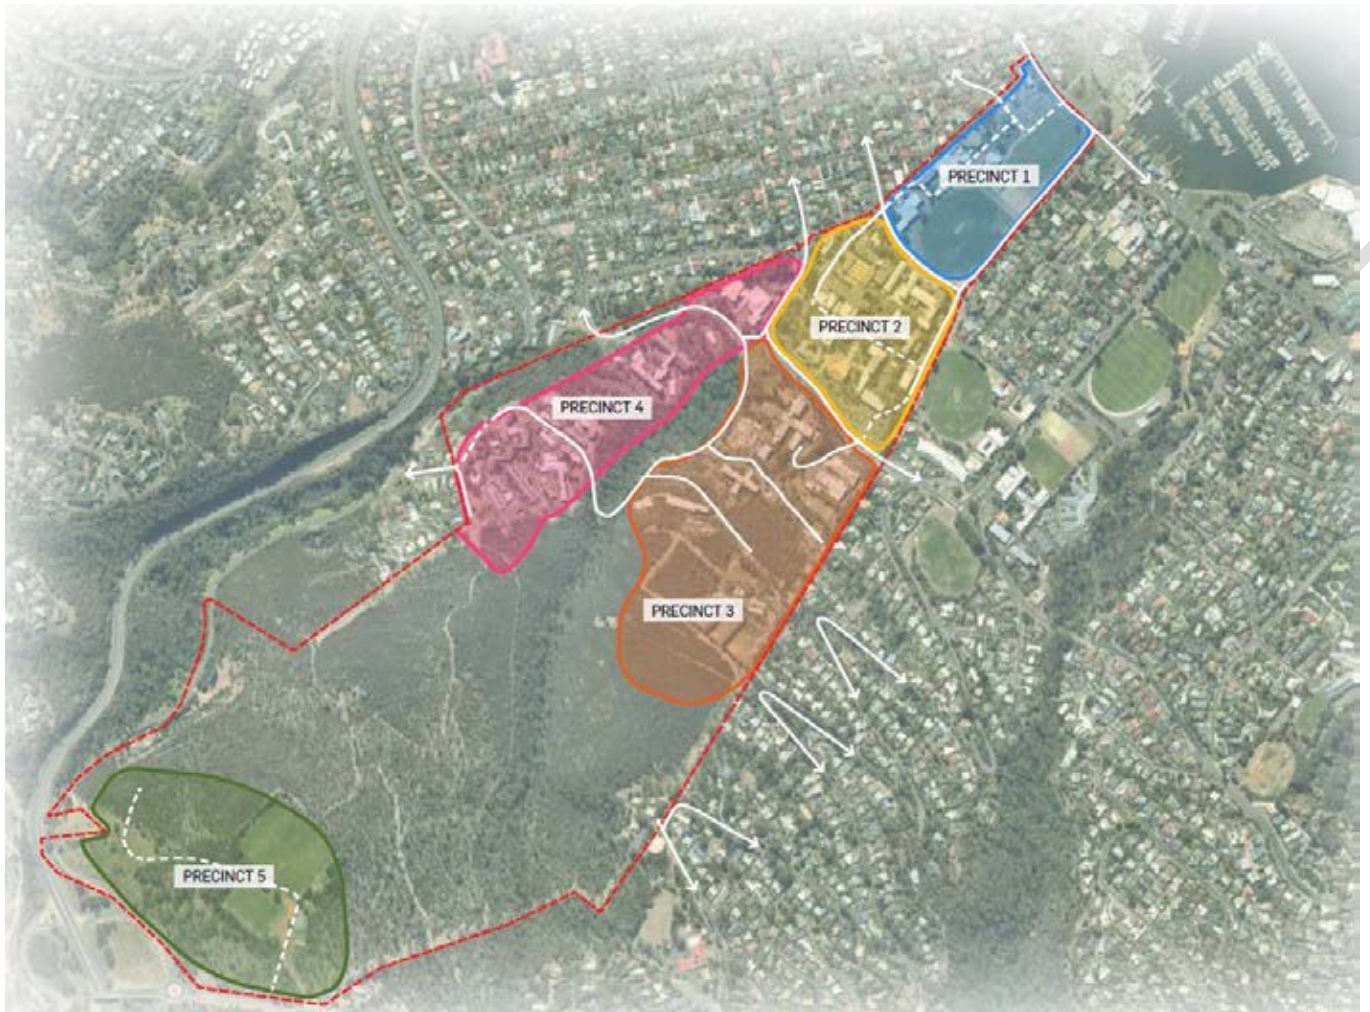
Figure 2.1 Precinct Plan

The assessment is based on the below extent of development.

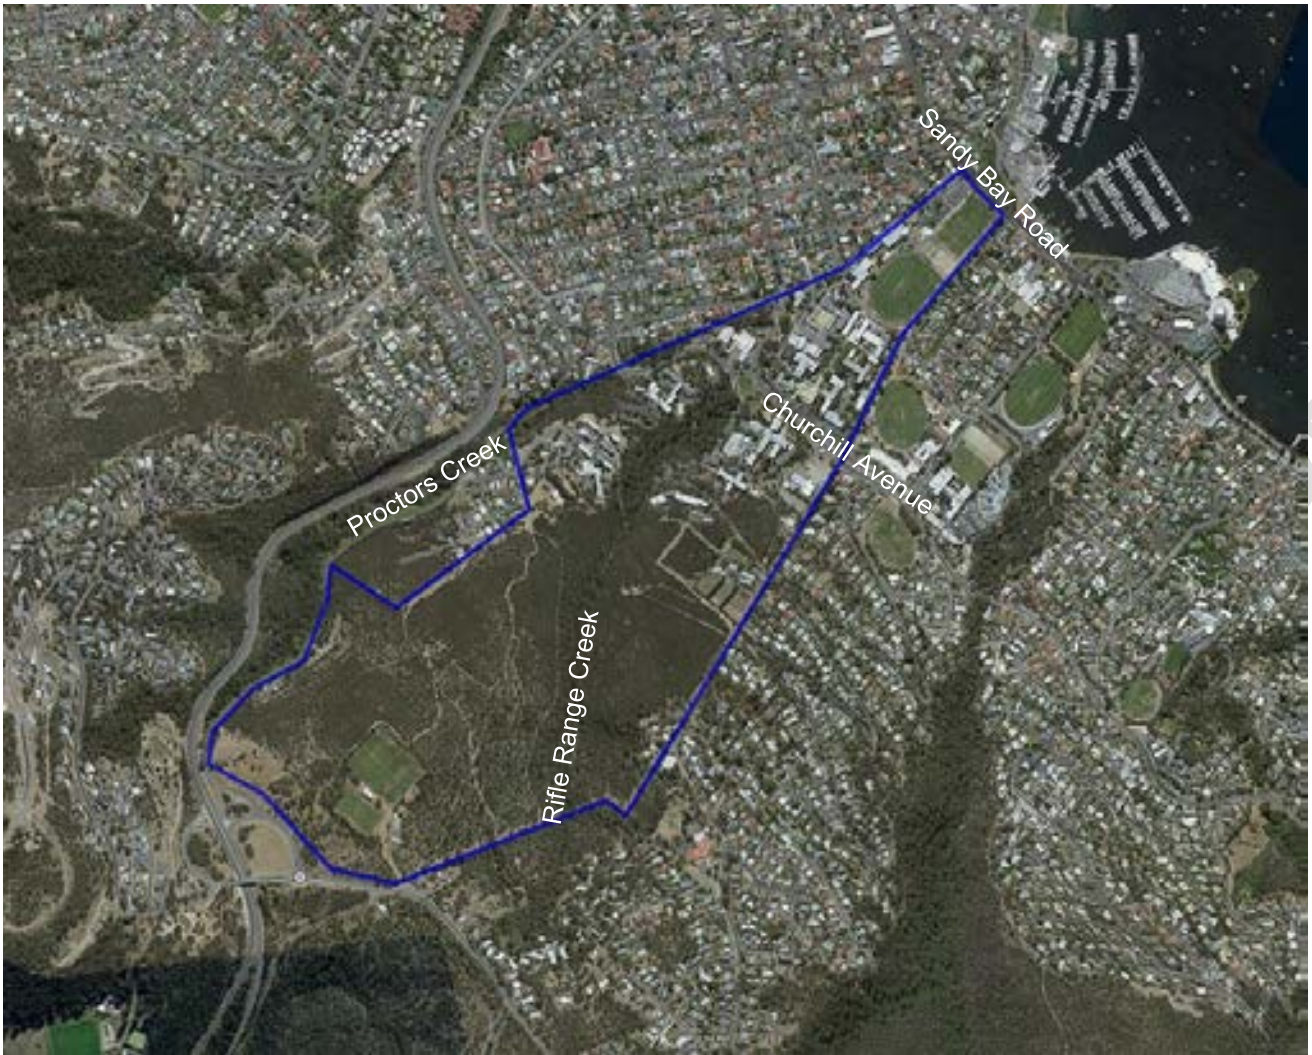
Figure 2.2 Site extent

The proposed Masterplan encompasses approximately 105 hectares of land spanning from Sandy Bay Road to Olinda Grove (Figure 2.2). The Site contains both heavily developed land on the lower portion (the existing main University campus) along with large areas of undeveloped bushland on the higher slopes. The Site is intersected by Churchill Avenue.

The lower portion of the Site is currently well serviced due to its largely urban landscape, whereas service availability in the upper portion of the Site is scarce due to its more natural and undeveloped condition. The Site also contains two significant natural watercourses, Proctor's Creek and Rifle Range Creek, both of which collect overland flow from the upper Mt. Nelson catchments and flow down the Site, before being piped into large culverts and discharged into the Derwent River.
