University of Tasmania Sandy Bay Masterplan

Conservation Management Plan (Volume 2)

UTAS Sandy Bay Campus
Building Data Sheets
Volume 2

September 2021

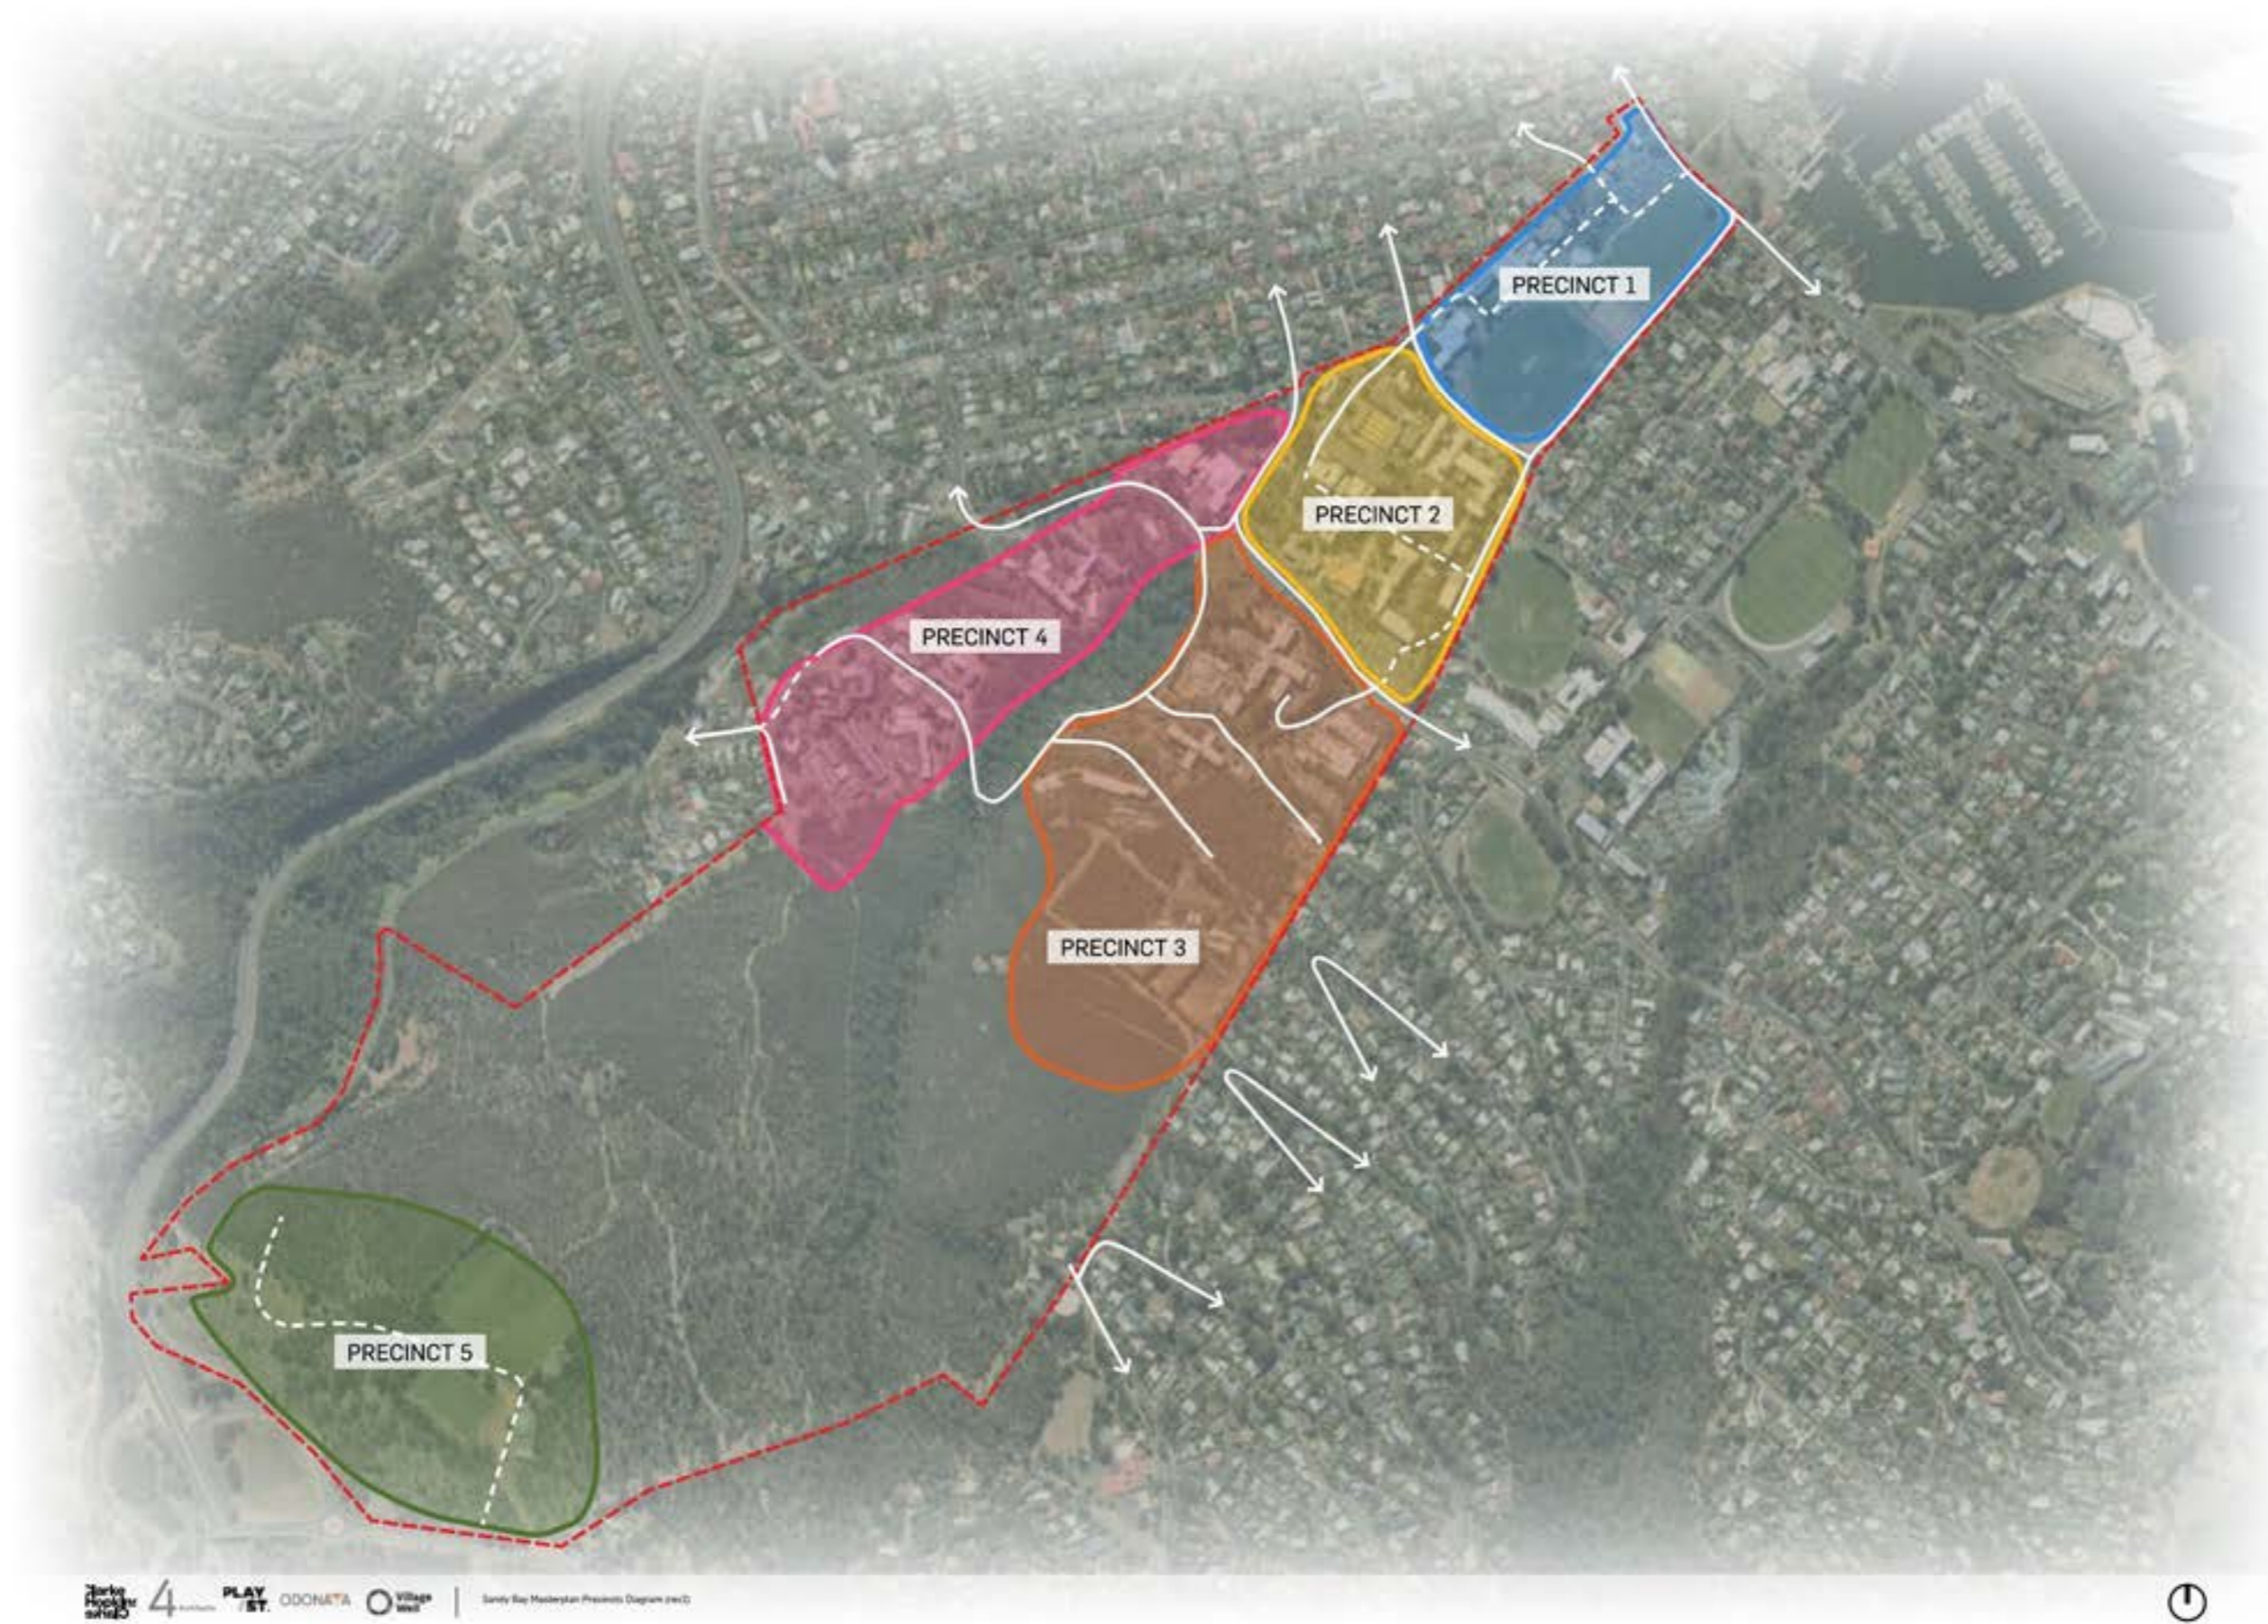
Figure 3 Investigation Areas

The Site has been divided into five precincts for the master planning exercise; see the designated areas in **Figure 3**. For the current University of Tasmania's Site plan see **Figure 4**.

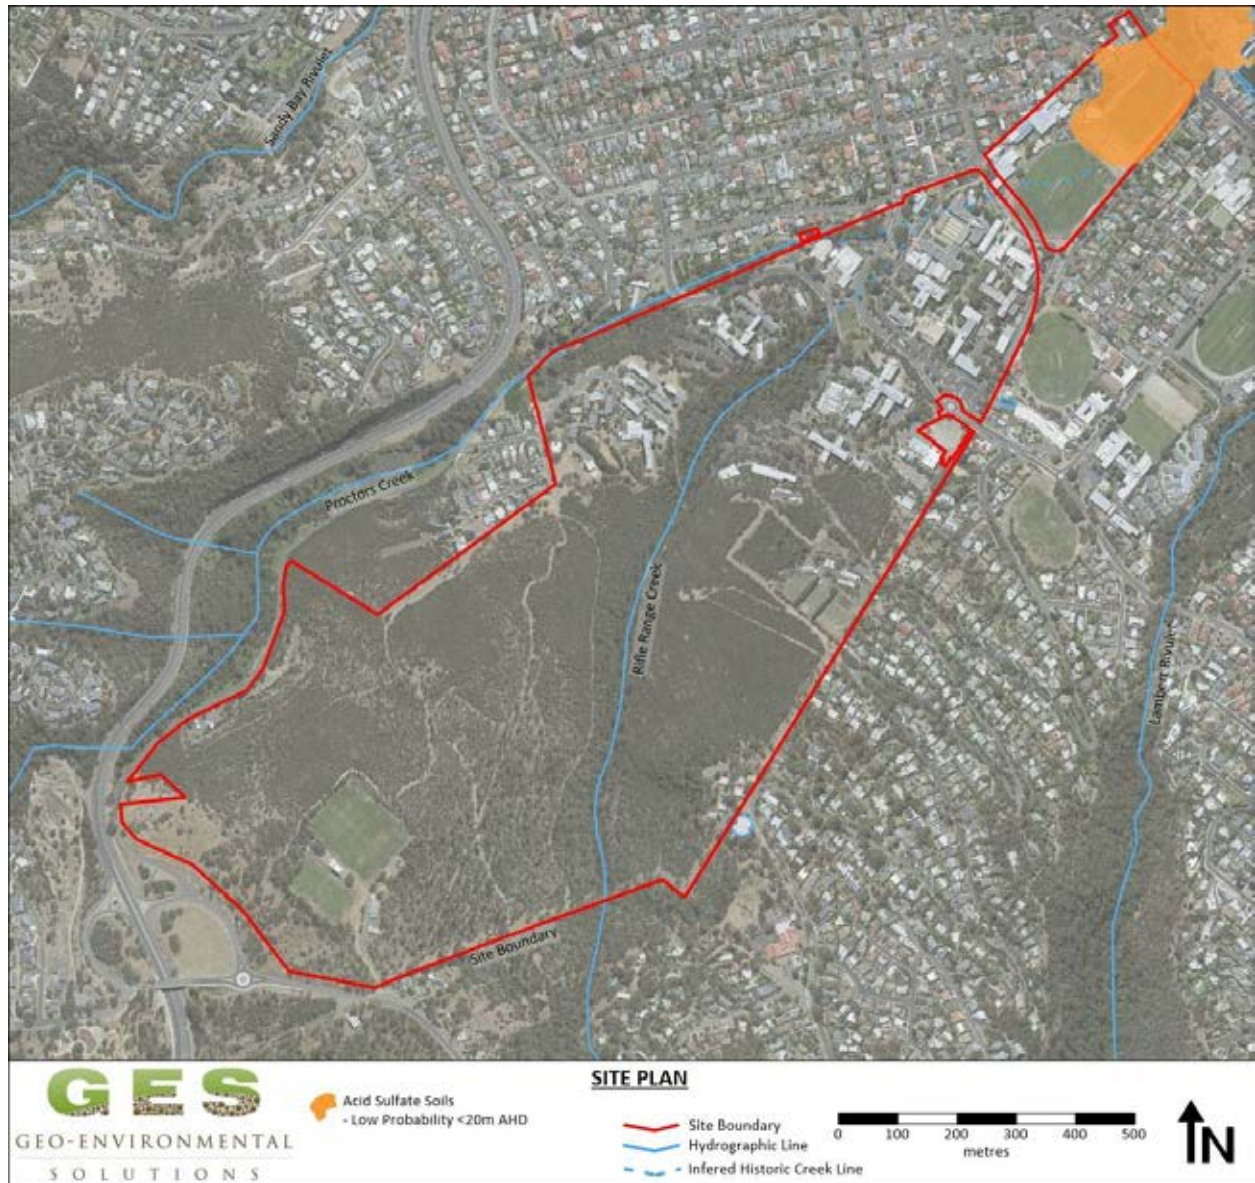
Figure 5 Acid Sulfate Soils Mapping

According to the Land Information Service Tasmania (LIST) database, the lower portion of Precinct 1 may contain low Level acid sulfate soils (ASS). Acid sulfate soils can be an issue for construction and excavation if sediments are exposed to oxygen, or infrastructure is placed into the acid bearing sediments.

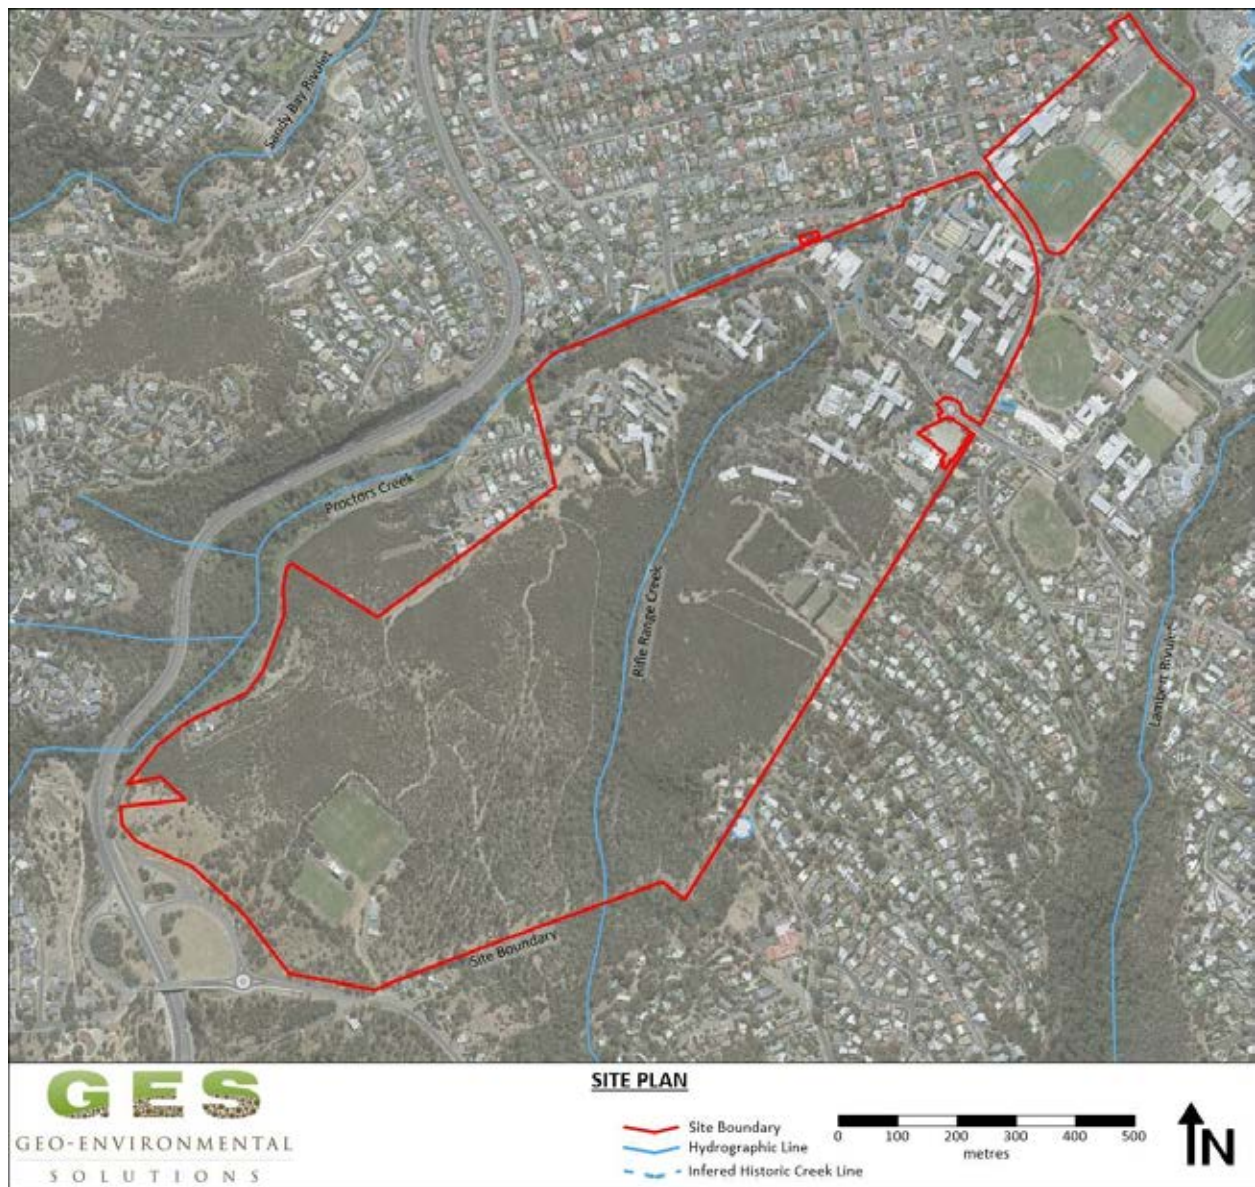
Figure 8 Topography and drainage

There is a great variation in elevation of the Site, the lower north-eastern end of the Site is 5m above sea Level (ASL) the highest point, the south western end of the property is 255m ASL. Two creeks converge on the lower part of the Site; Proctors Creek and Rifle Range Creek; and drain towards the north east towards the River Derwent at Marieville Esplanade; see figure 8.
